LOCAL FLOOD PROTECTION PROJECT INSPECTION REPORT

Project: **Fitchburg, Massachusetts**

FITCHBURG, MASSACHUSETTS - LOCAL PROTECTION PROJECT

SEMI-ANNUAL INSPECTION

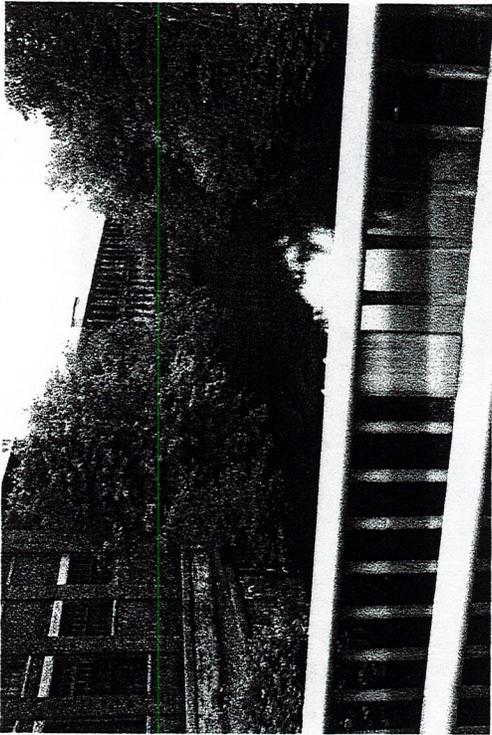
Photo 1: Fitchburg LPP, 29 May 02, looking upstream from the Oak Hill Road Bridge

Looking upstream - Significant vegetation, including small trees, is present on both sides of the channel. The shoal on the left bank immediately above and under the bridge appears to be expanding (see photograph # 1).

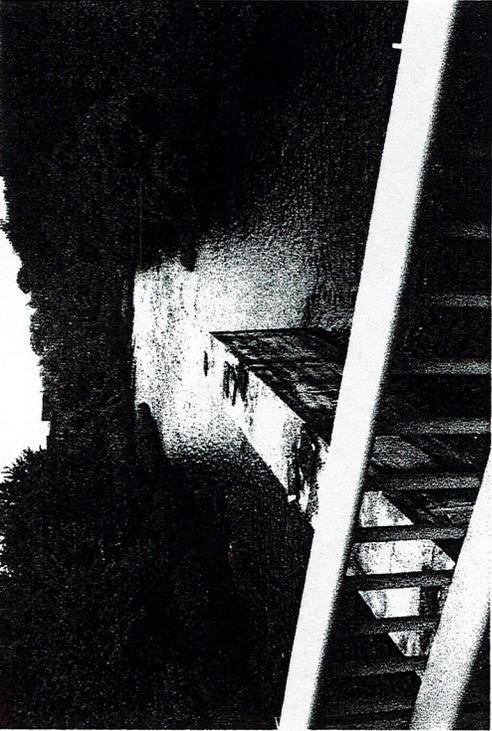
Photo 5: Fitchburg LPP, 29 May 02, looking upstream from the Sheldon Street Bridge

Looking upstream - **Undesirable woody vegetation and shoals are present on both banks** (see photograph # 5).

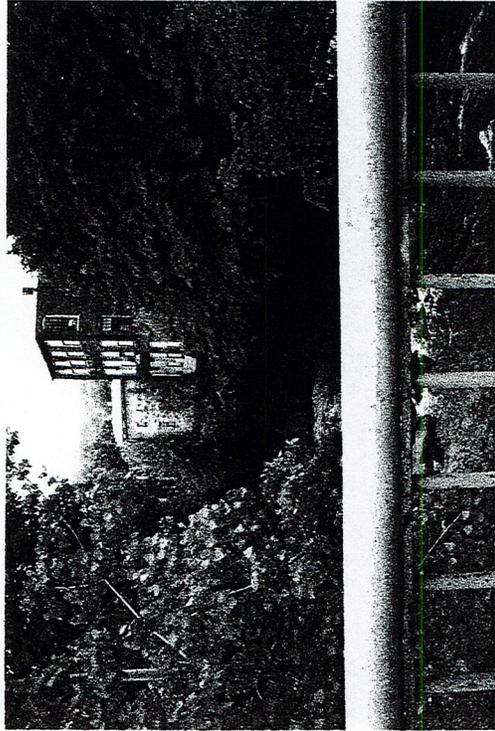
Photo 7: Fitchburg LPP, 29 May 02, looking upstream from the Lower River Street Bridge

Looking upstream - **Vegetative growth is present along both banks** (see photograph # 7).

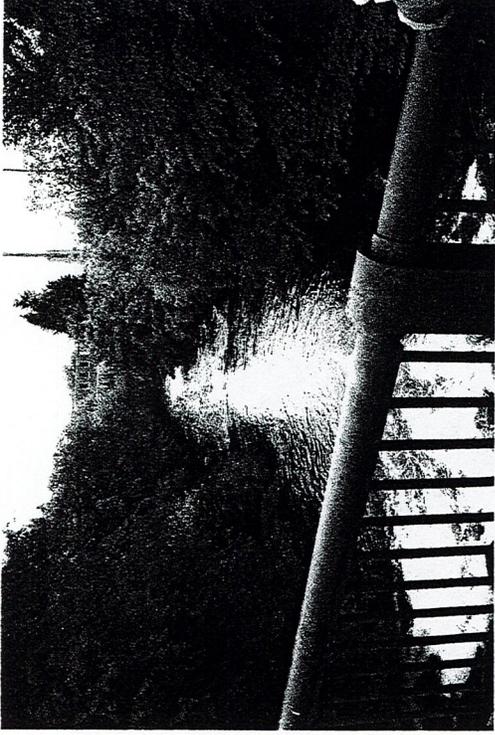
Photo 6: Fitchburg LPP, 29 May 02, looking downstream from the Lower River Street Bridge

Looking downstream - **A large shoal is present on the left bank. Vegetation is present on both banks** (see photograph # 6).

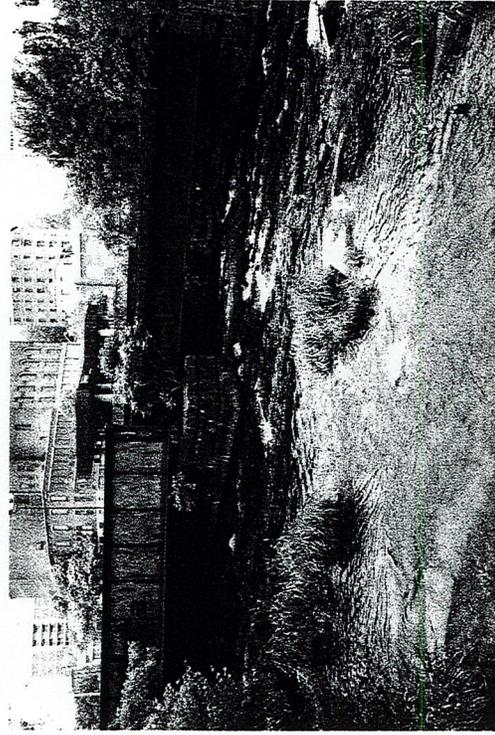
Photo 8: Fitchburg LPP, 29 May 02, looking upstream from the Laurel Street Bridge

Looking upstream - **Major shoaling has taken place in the entire area of the upstream railroad crossing. A large shoal, which is nearly covered with vegetation, restricts the western span and half of the center span. This is a significant restriction, which has decreased the discharge capacity of the channel by nearly 33% and needs to be corrected promptly (see photograph # 8). The shoals and trees should be removed.**

- b. The channel immediately upstream, underneath and downstream of the railroad bridge located just upstream of the Laurel Street Bridge.**
- c. The channel from downstream of the Circle Street Bridge to Laurel Street Bridge.**
- d. The channel from upstream of the Daniel Street Bridge to the Circle Street Bridge.**
- e. The channel from the Laurel Street Bridge to downstream of the Water Street Bridge.**
- f. All remaining stretches of the North Nashua River channel within the project limits (from the project start upstream of the Oak Hill Road Bridge to downstream of the Airport Road Bridge) as noted in the inspection report.**

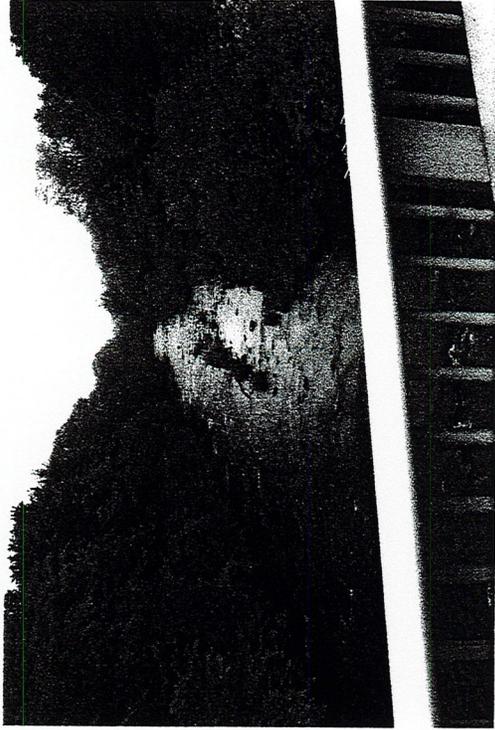
Photo 12: Fitchburg LPP, 29 May 02, looking upstream from the Bemis Road Bridge

Looking upstream - **Small trees have become established on the riprap protection and at the toe of the slope along the right bank** (see photograph # 12). This vegetation should be removed.
