DEPARTMENT OF THE ARMY
US ARMY CORPS OF ENGINEERS
NEW ENGLAND DISTRICT
696 VIRGINIA ROAD
CONCORD MA 01742-2751

The most recent routine inspection (RI) of the federally constructed North Nashua River Flood Damage Reduction (FDR) System, in the city of Fitchburg, Massachusetts, was conducted on June 14, 2018. Enclosed is a detailed inspection report for the City's records.

Flood Damage Reduction Segment / System Inspection Report

Name of Segment / System: North Nashua River

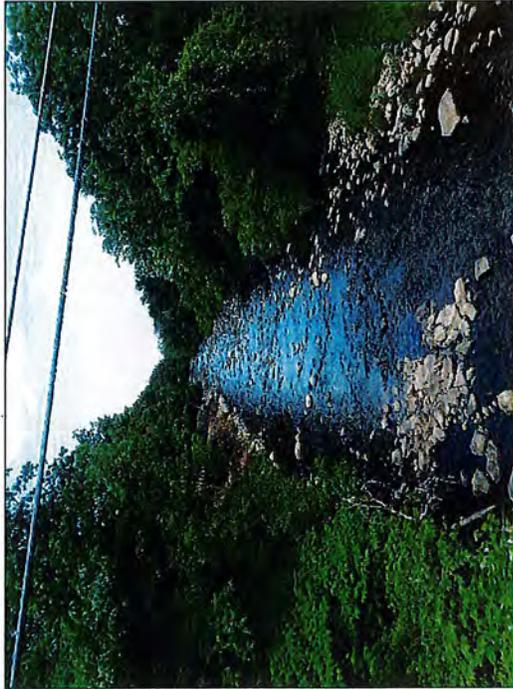
Photo 1: Bemis Road: View of vegetation and shoaling downstream.

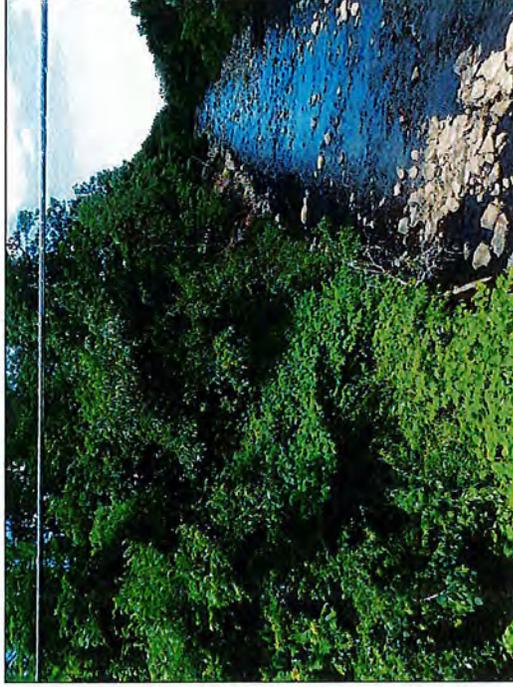
Photo 2: Bemis Road: View of heavy vegetation and shoaling.

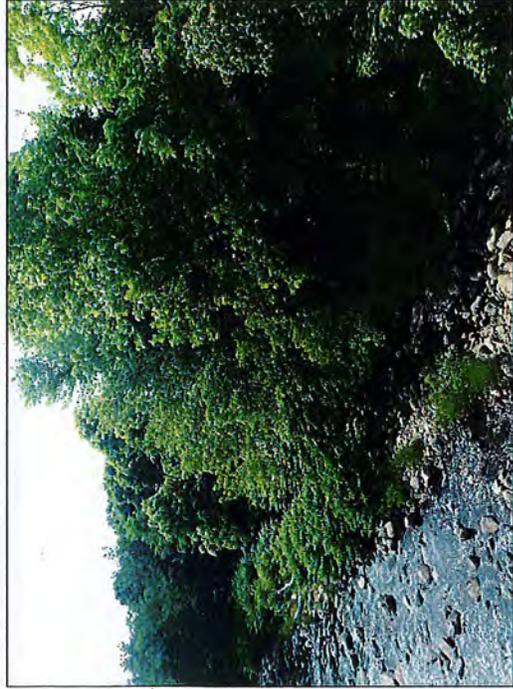
Photo 3: Bemis Road: View of heavy vegetation along the upstream left bank.

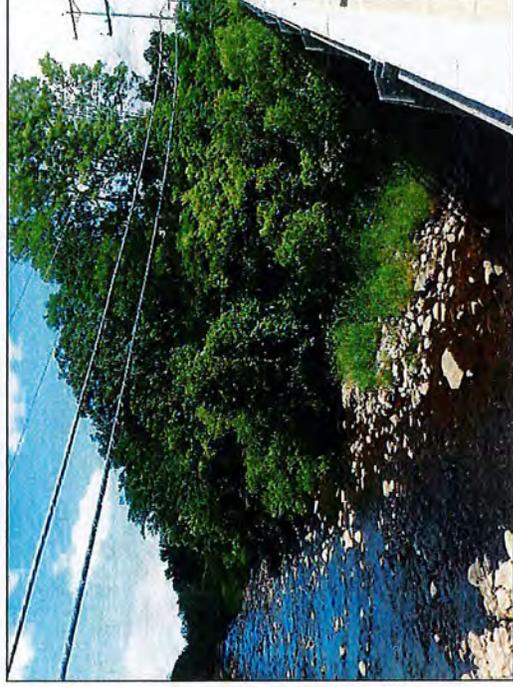
Photo 4: Bemis Road: View of heavy vegetation and shoaling.

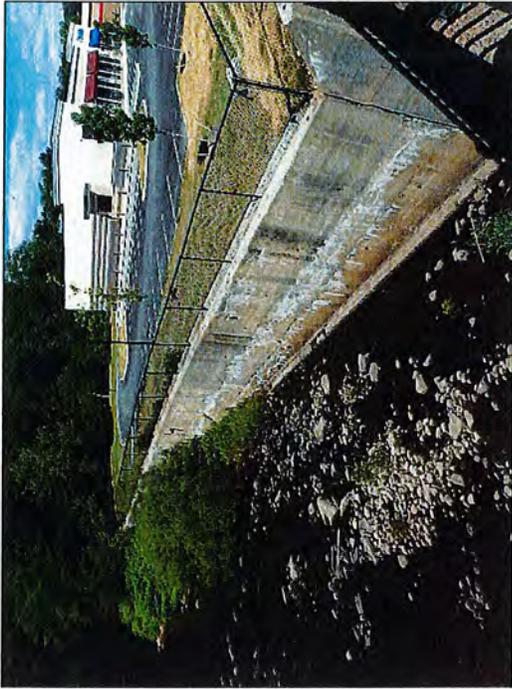
Photo 5: Water Street: View of vegetation and shoaling.

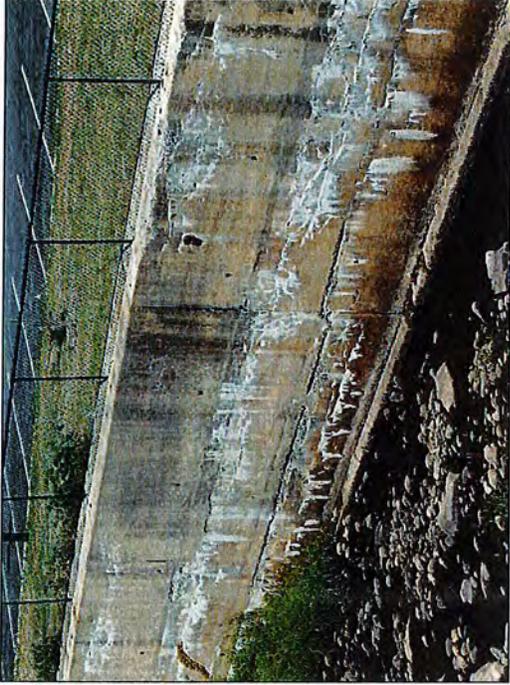
Photo 6: Water Street: View of efflorescence and shoaling along the upstream left bank.

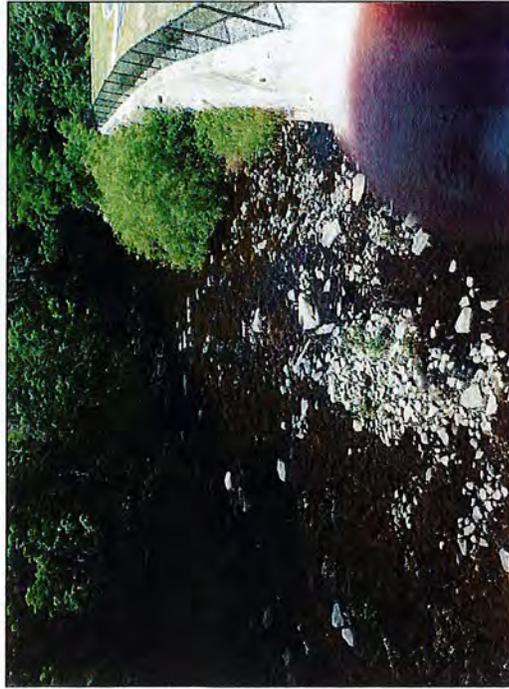
Photo 7: Water Street: View of heavy vegetation along the upstream left bank, below the fence.

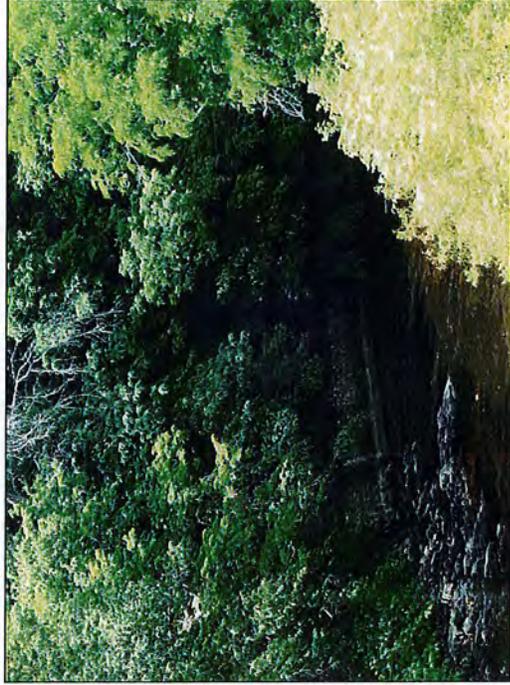
Photo 8: Water Street: View of vegetation along the upstream right bank.

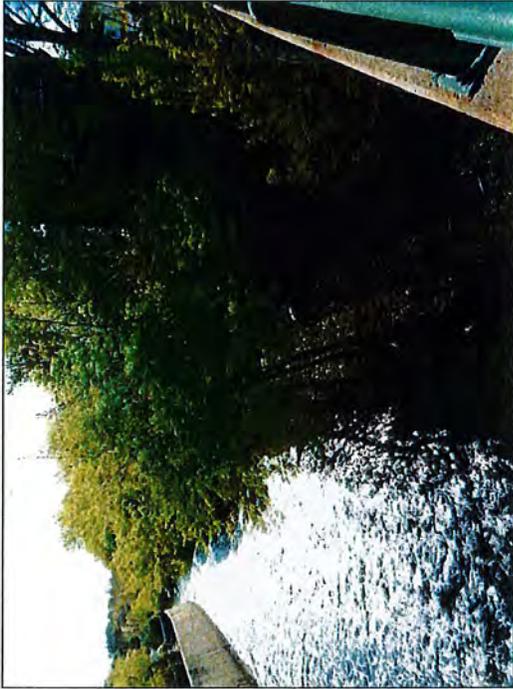
Photo 9: Water Street: Heavy vegetation and shoaling on the downstream right bank.

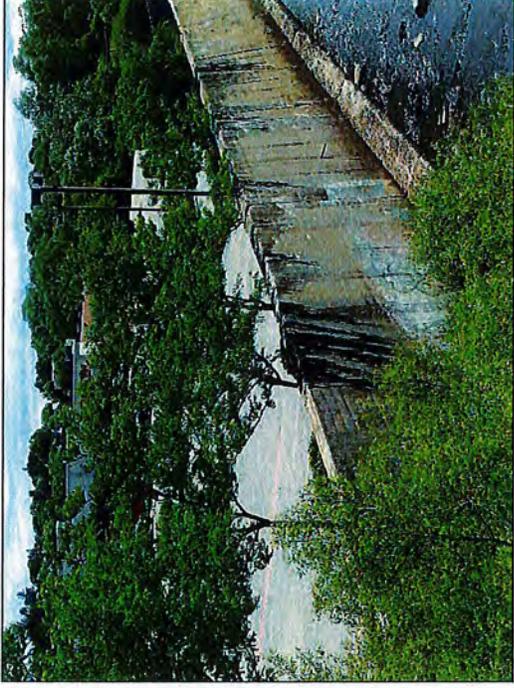
Photo 10: Water Street: View of floodwall cracks, trees on upper and lower flat spaces, and shoaling along the downstream right bank.

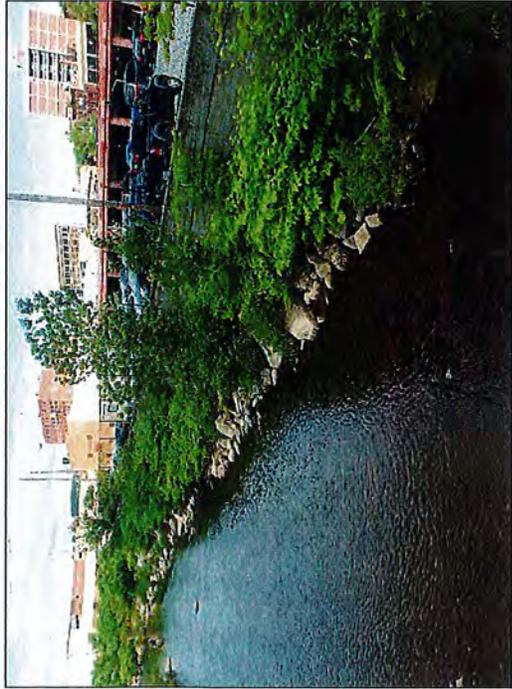
Photo 11: Commercial Street: Heavy vegetation along the upstream left bank.

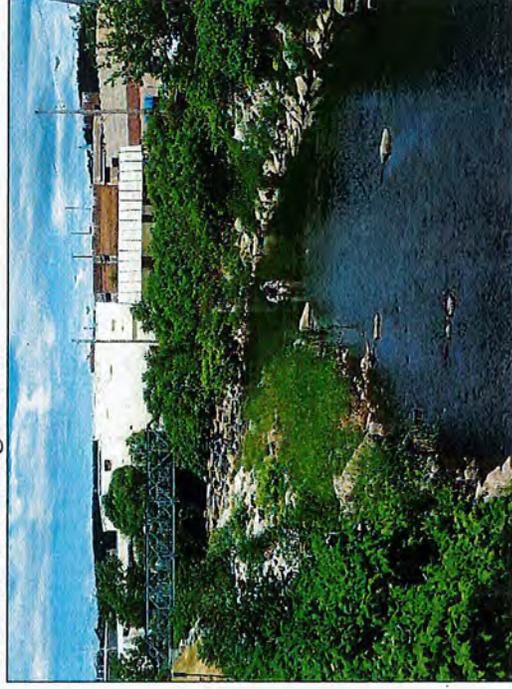
Photo 12: Commercial Street: Vegetation along the upstream right bank.

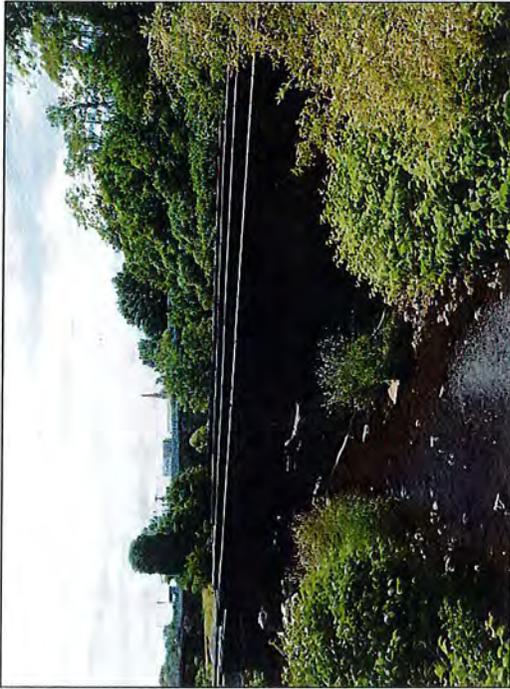
Photo 13: Commercial Street: Heavy vegetation on left bank looking downstream.

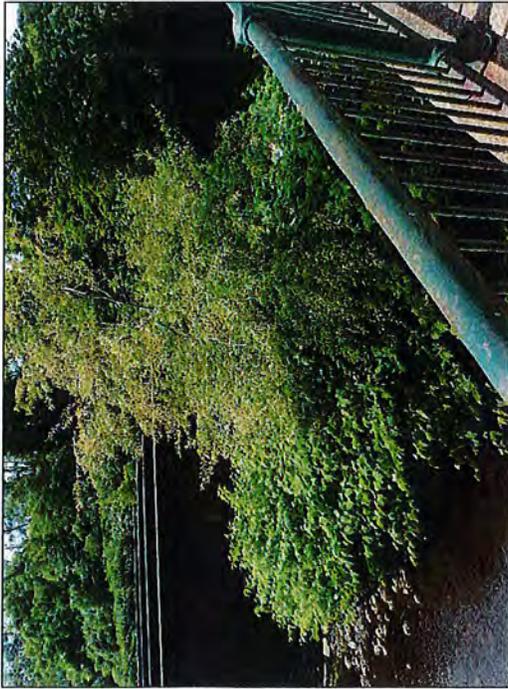
Photo 15: Commercial Street: Heavy vegetation on right bank looking downstream.

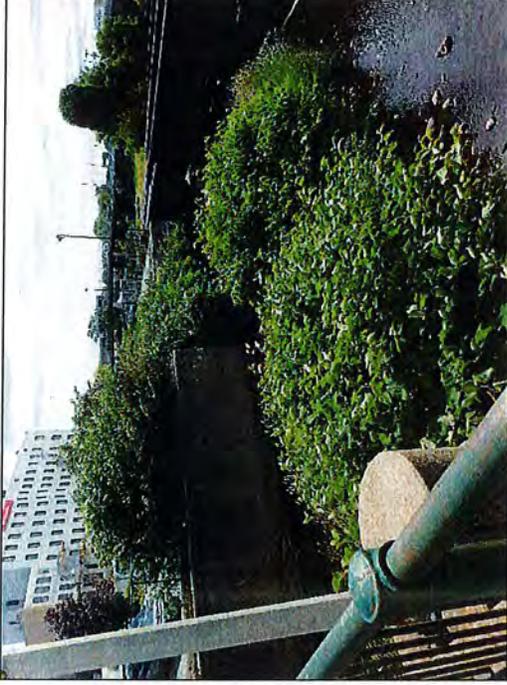
Photo 14: Commercial Street: Heavy vegetation on left bank looking downstream.

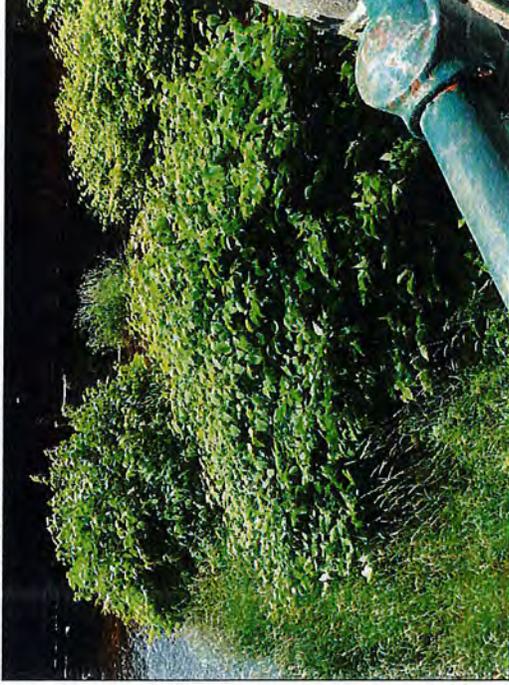
Photo 16: Commercial Street: Close-up of heavy vegetation on right bank looking downstream.

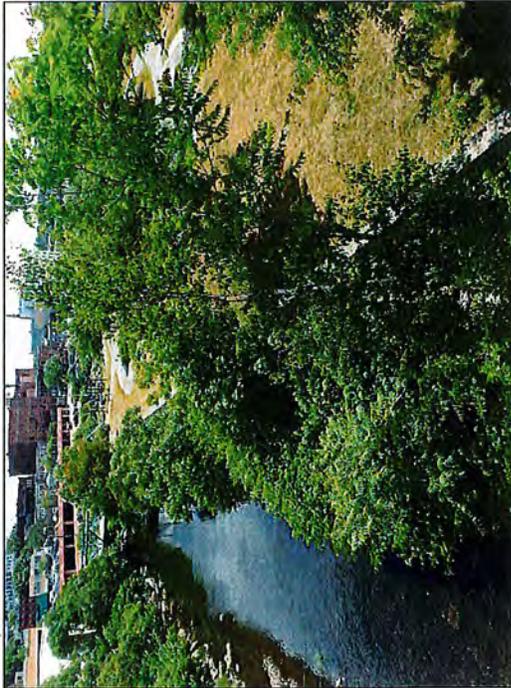
Photo 17: Commercial - Putnam Street: View of heavy vegetation downstream on the right bank.

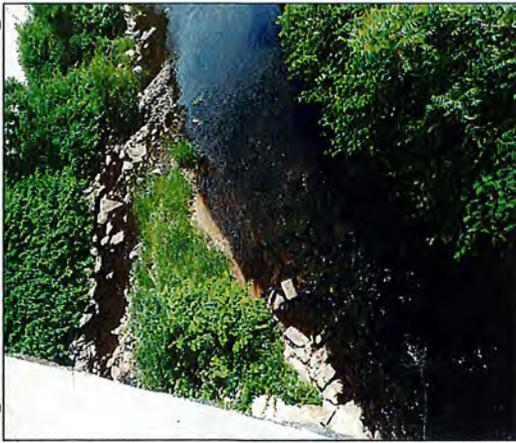
Photo 19: Commercial-Putnam Street: Heavy vegetation and shoaling looking downstream.

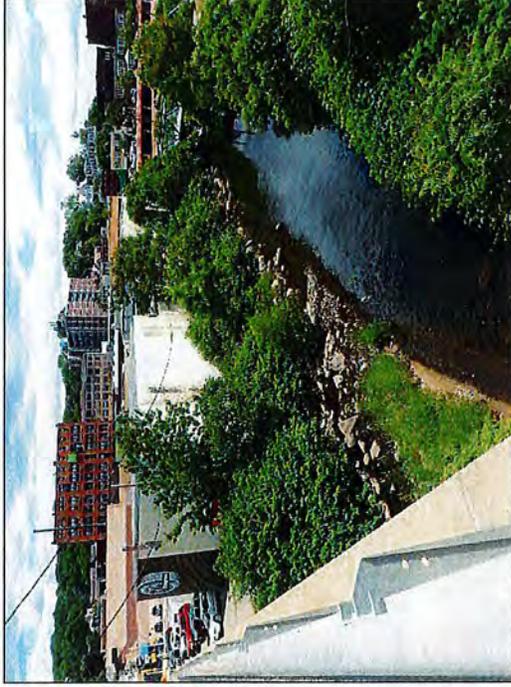
Photo 18: Commercial – Putnam Street: View of heavy vegetation downstream on the left bank.

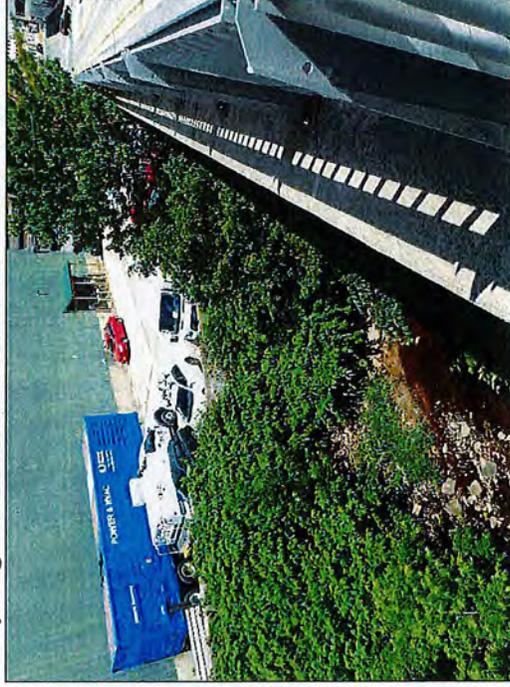
Photo 20: Putnam Street: Heavy vegetation upstream on the left bank.

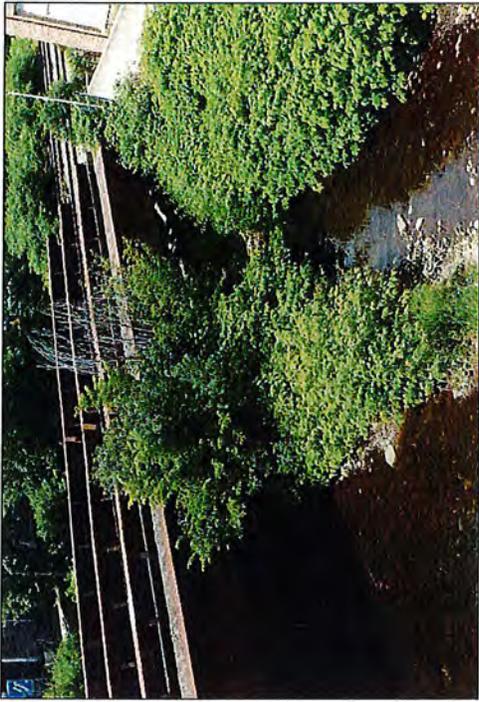
Photo 21. Putnam Street: Heavy vegetation and shoaling on upstream left bank.

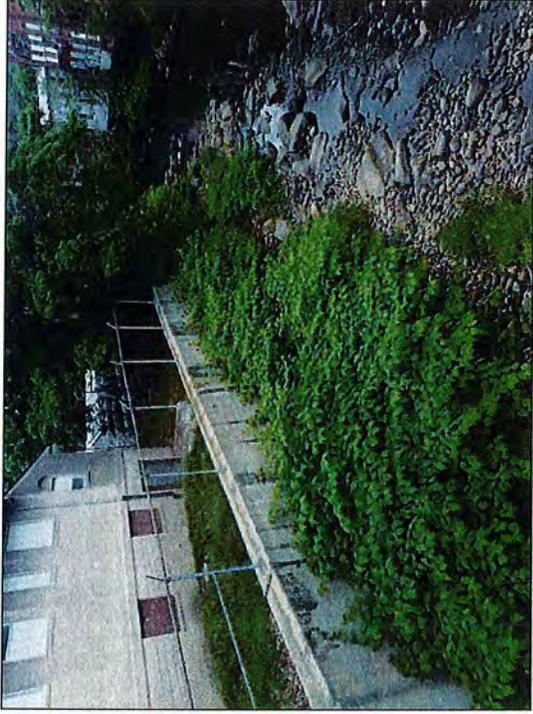
Photo 22: Circle Street: Heavy vegetation and shoaling upstream right bank.

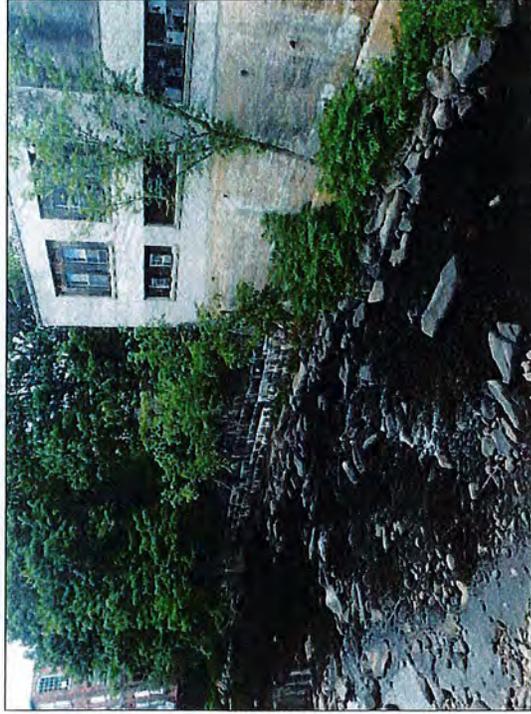
Photo 23: Circle Street: Heavy vegetation and shoaling upstream left bank.

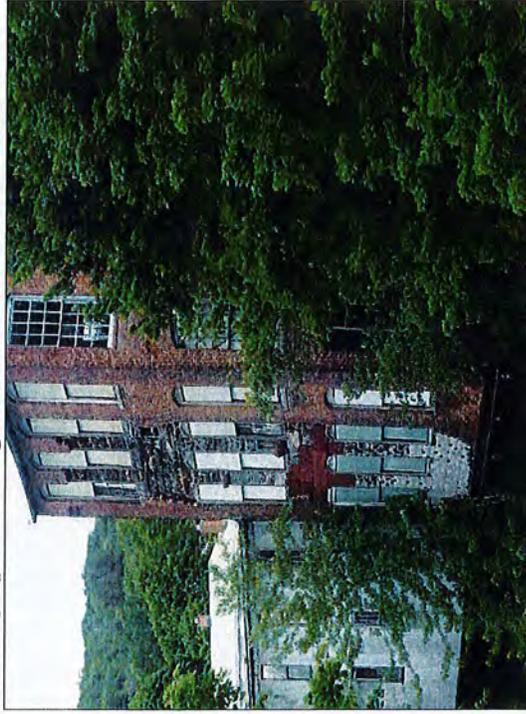
Rated Item	Rating	Rating Guidelines	Location/Remarks/Recommendations
1. Vegetation and Obstructions	A	No obstructions, vegetation, debris, or sediment accumulation within the channel. Concrete channel joints and weep holes are free of grass and weeds.	Significant vegetation consisting of large brush and trees greater than 2-inch diameter along the channel slopes of the entire project, with greater than 6-inch diameter present at each inspected segment. Vegetation needs to be cleared to prevent any reduction in flow during a flood event in accordance with Engineering Technical Letter 1110-2-583. Refer to photos 1-56. (U) Ornamental trees planted adjacent to the floodwall within the shopping complex by the Water Street bridge. Refer to photo 10. Remove trees. (M) A three story brick building wall on the Circle Street, upstream left bank is failing, with debris falling into the channel. The wall is bowed vertically, and may be also bowed toward the channel. If the wall collapses, it could block the channel. Work with the building owner to stabilize the wall or monitor the building and remove debris from the channel. Refer to photo 24. (U)

Photo 24. Circle Street: Failing 3-story building wall overhanging upstream, left bank.

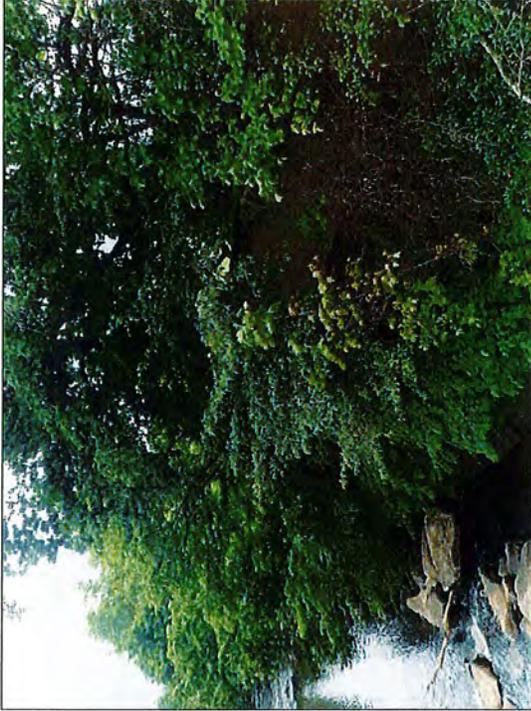
Photo 26: Circle Street: Heavy vegetation and shoaling on downstream right bank.

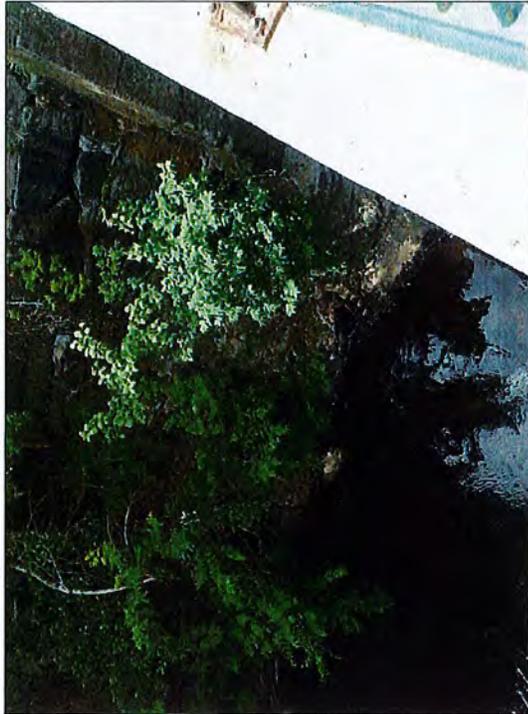
Photo 27: Circle Street: Vegetation growing out of masonry and rock joints, downstream, right bank.

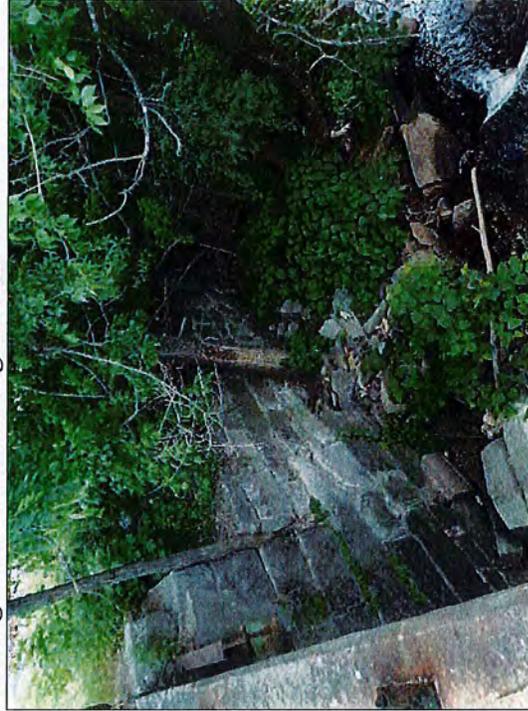
Photo 28: Circle Street: Trees up to 6 inch diameter growing out of block joints downstream, left bank.

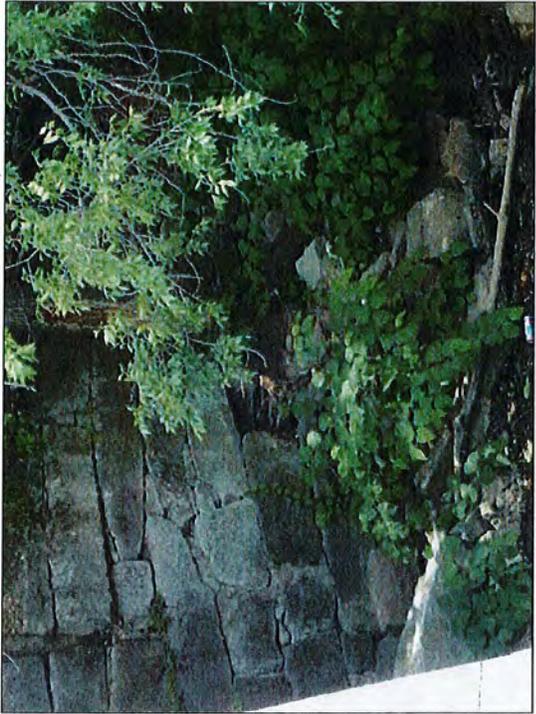
4. Erosion	U	No head cutting or horizontal deviation observed.	Channel embankments could not be inspected due to high vegetation. Trees on the downstream left bank of the Circle Street bridge are displacing stone blocks out of the retaining
	M	Head cutting and horizontal deviation evident, but is less than 1 foot from the designed grade or cross section.

Photo 29: Circle Street: 6 inch diameter tree displacing blocks out of stone wall, downstream, left bank.

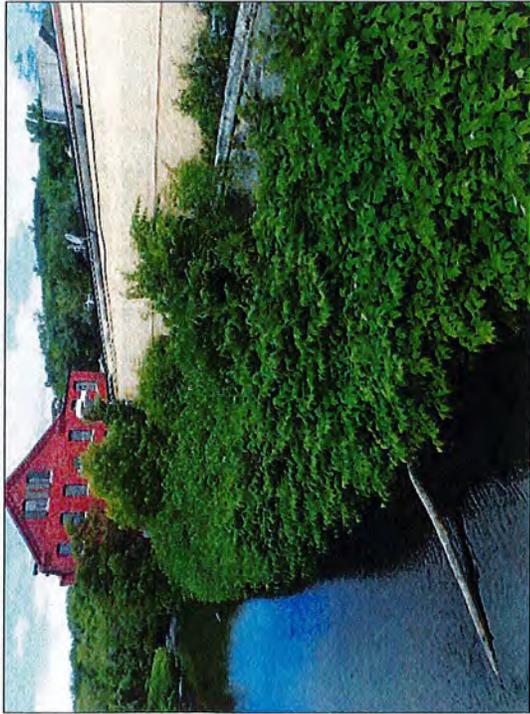
Photo 31: River/Main Street: Heavy vegetation and shoaling upstream left bank.

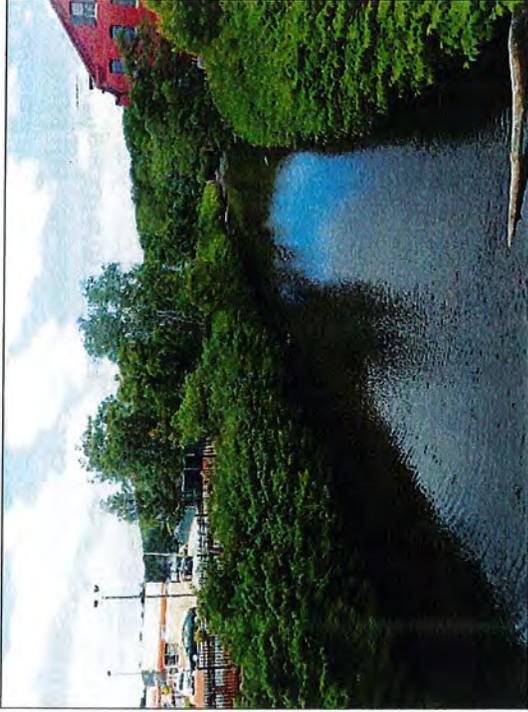
Photo 30: River/Main Street: Heavy vegetation and shoaling upstream right bank.

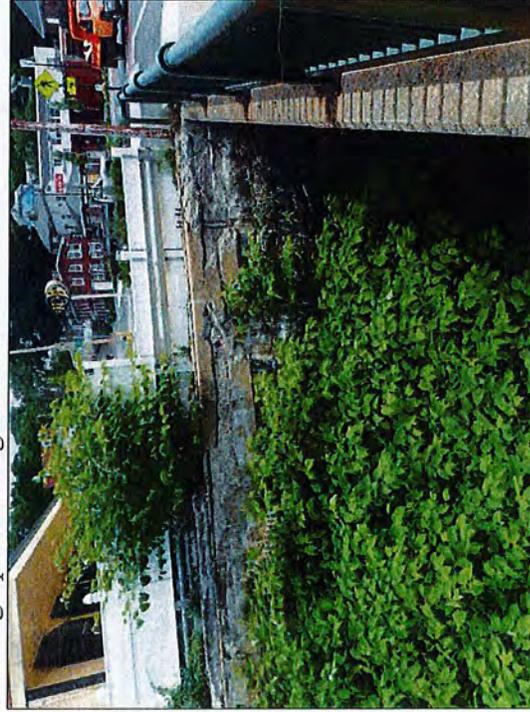
Photo 32: River/Main Street: Heavy vegetation on and within stone block joints, upstream left bank.

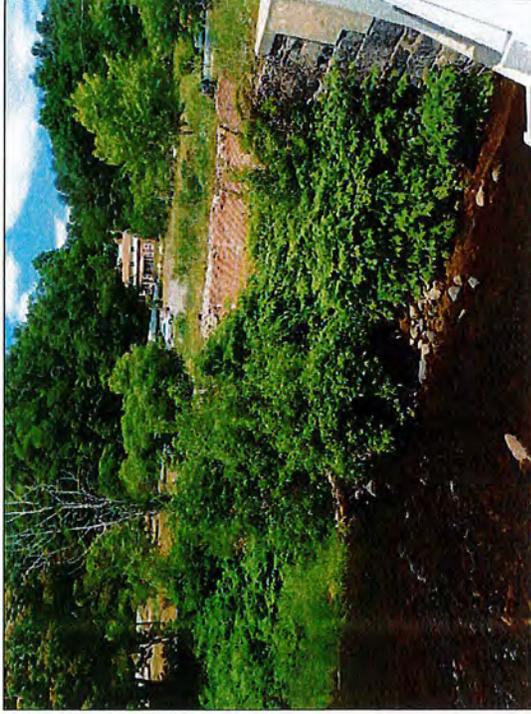
Photo 34: Sheldon Street: Deteriorated brick outfall (flowing), vegetation, upstream left bank.

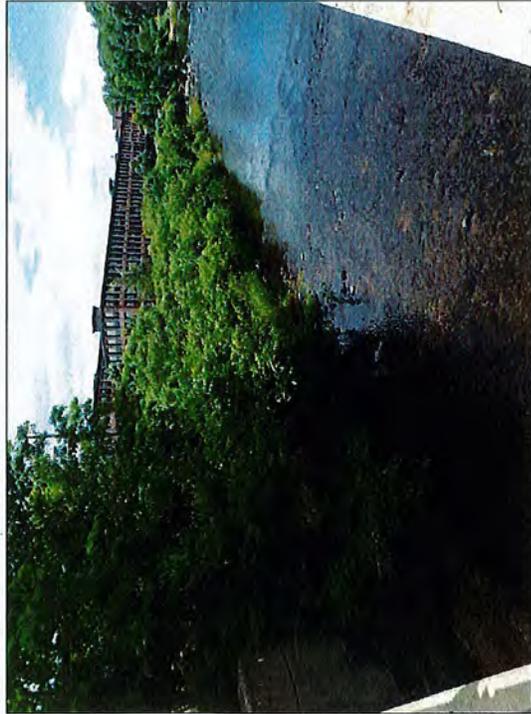
Photo 35: Sheldon Street: Heavy vegetation, upstream left bank.

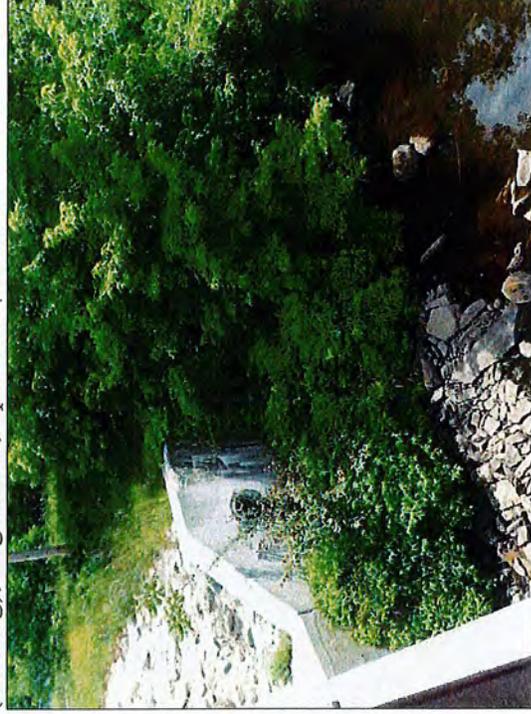
Photo 36: Sheldon Street: Heavy vegetation, upstream left bank.

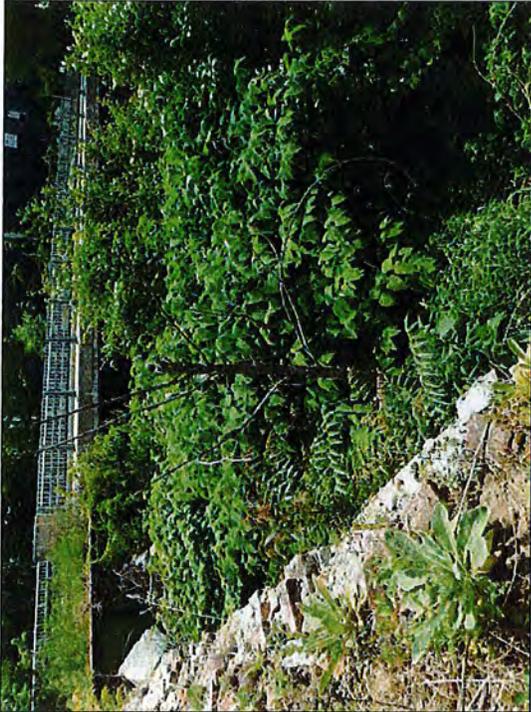
Photo 37: Sheldon Street: Heavy vegetation at brick outfall (flowing), upstream left bank.

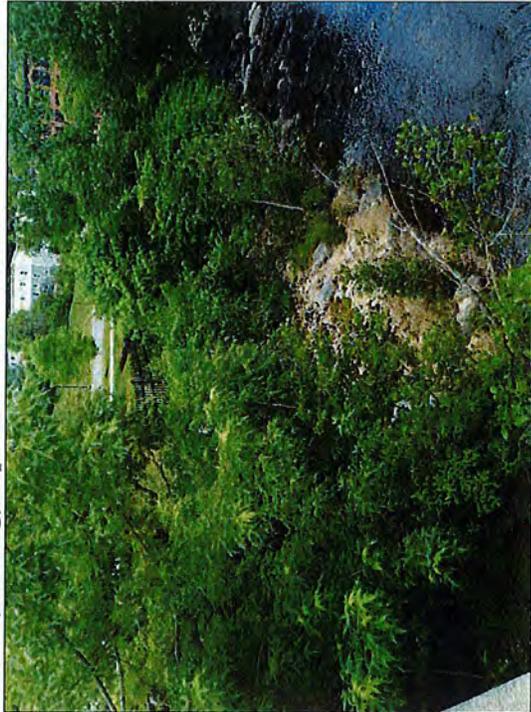
Photo 39: Sheldon Street: Heavy vegetation and shoaling downstream left bank.

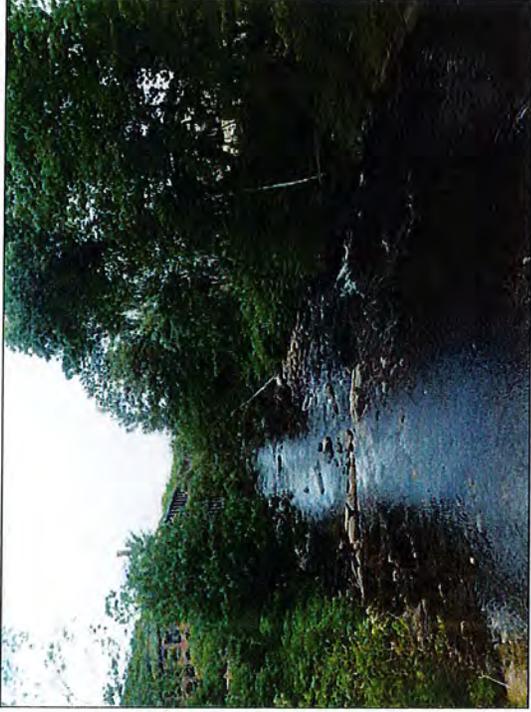
Photo 38: Sheldon Street: Heavy vegetation and shoaling downstream right bank.

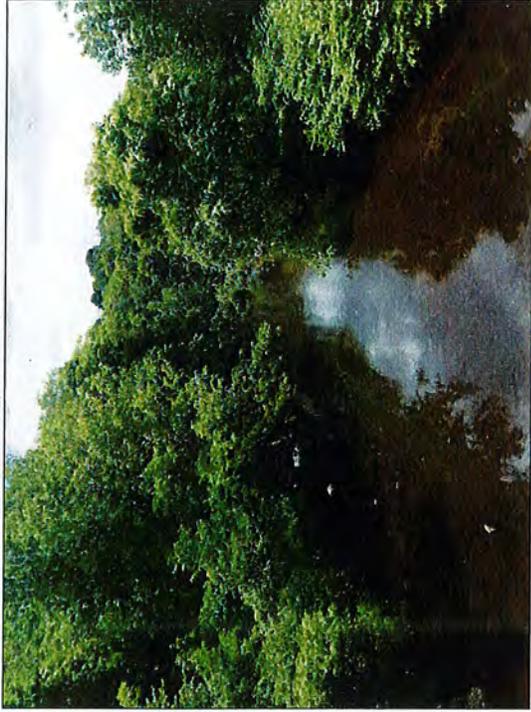
Photo 40: Kimball Street: Heaving vegetation upstream on left and right banks.

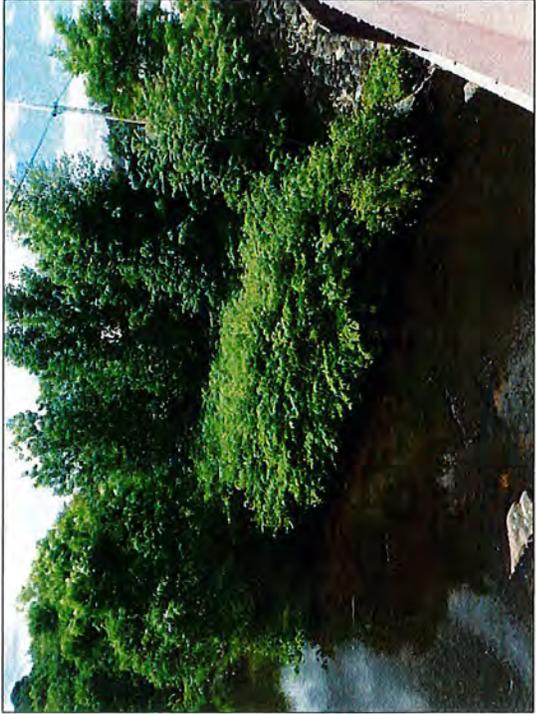
Photo 41: Kimball Street: Heaving vegetation upstream on right bank.

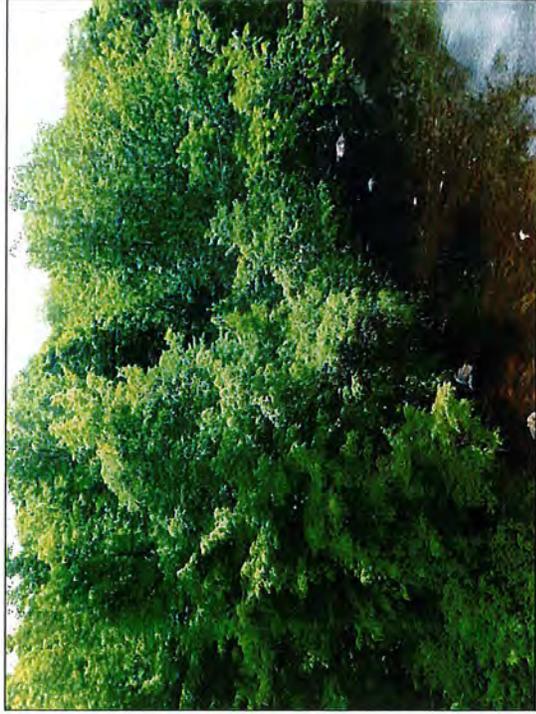
Photo 42: Kimball Street: Heaving vegetation upstream on left bank.

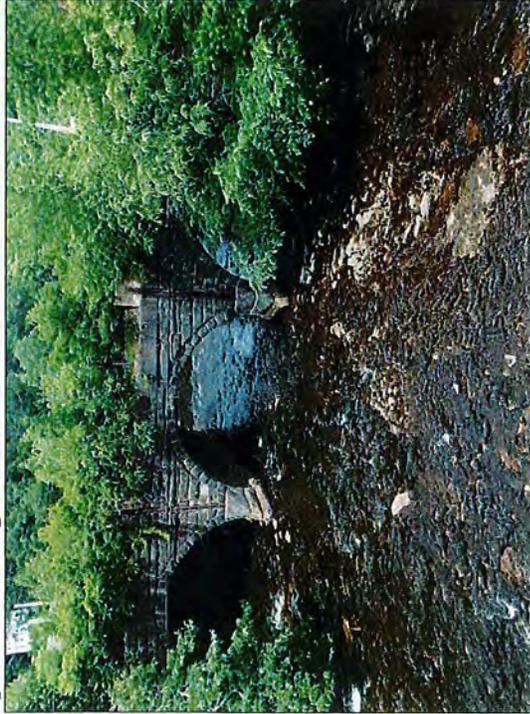
Photo 43: Kimball Street: Looking downstream to overgrown railroad bridge.

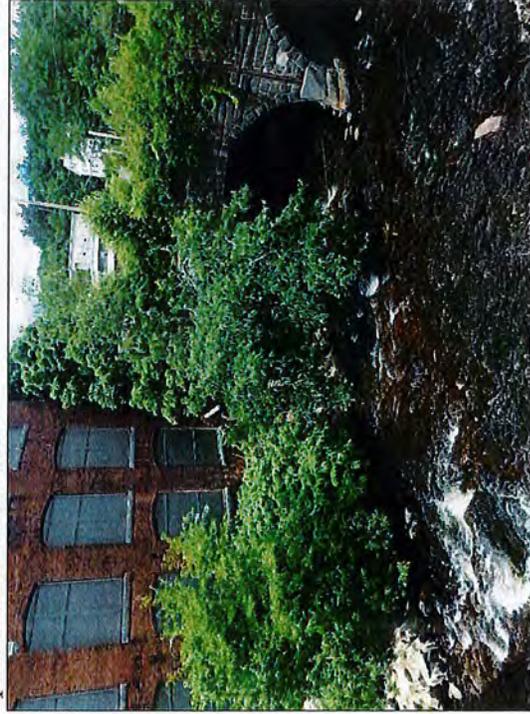
Photo 44: Kimball Street: Heaving vegetation on downstream left bank and railroad bridge.

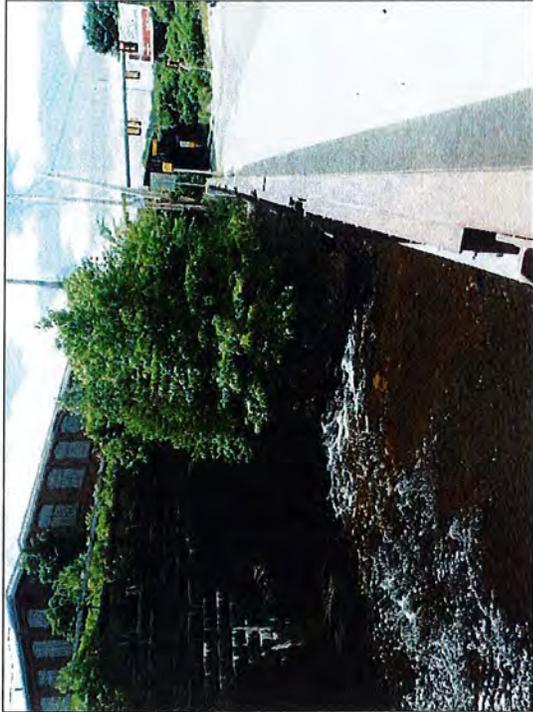
Photo 45: Kimball Street: Heaving vegetation on downstream right bank and railroad bridge.

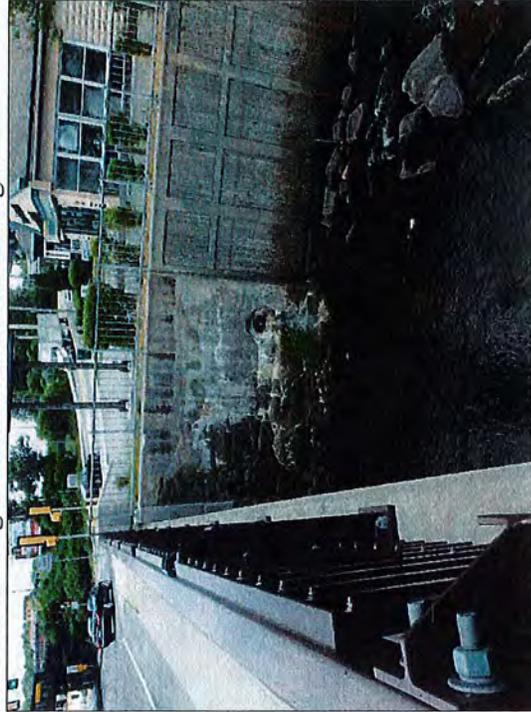
Photo 47: Daniels Street: Efflorescence at concrete-stone wall interface on upstream right bank.

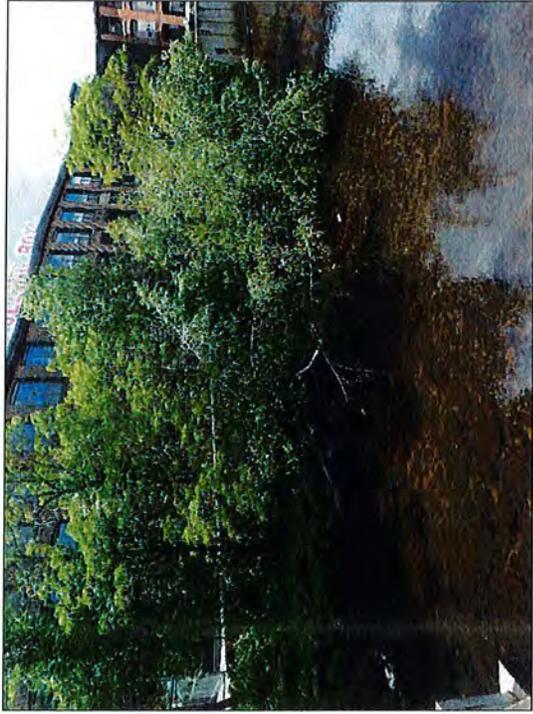
Photo 46: Daniels Street: Heavy vegetation and trees on upstream right bank.

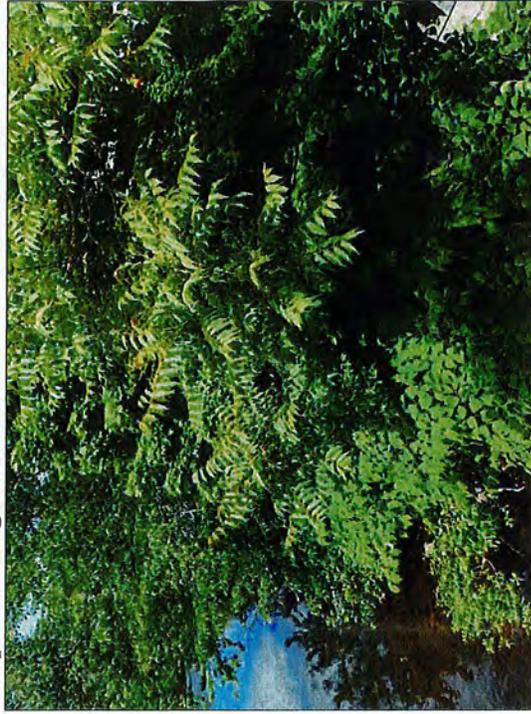
Photo 48: Daniels Street: Heavy vegetation on upstream left bank.

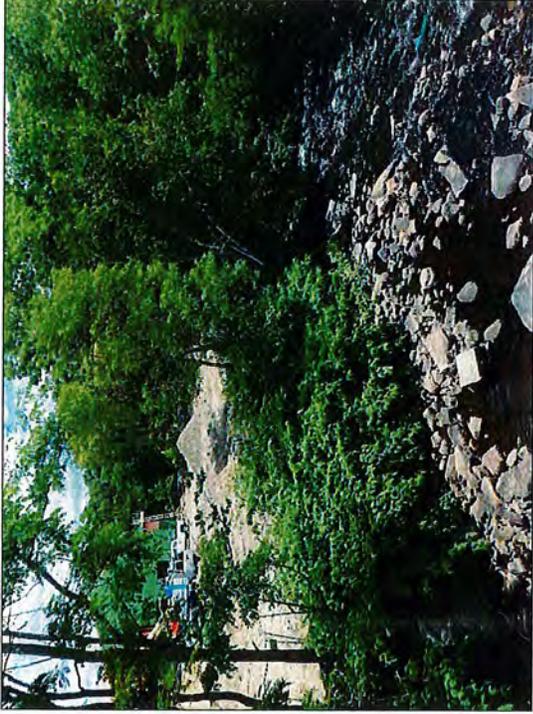
Photo 50: Daniels Street: Vegetation & trees bordering construction site, downstream left bank.

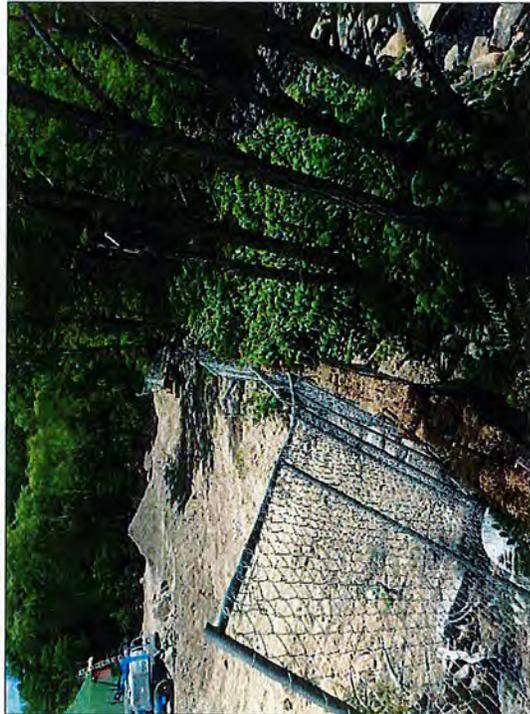
Photo 51: Daniels Street: Close-up of construction site bordering downstream left bank.

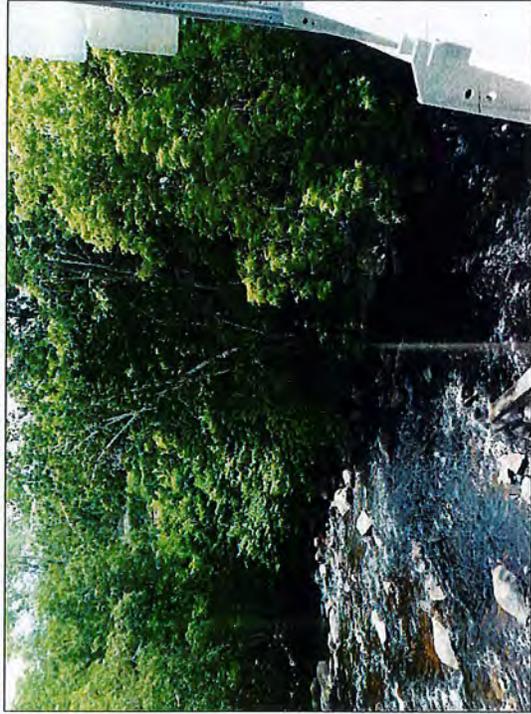
Photo 52: Daniels Street: Vegetation & trees bordering construction site, downstream right bank.

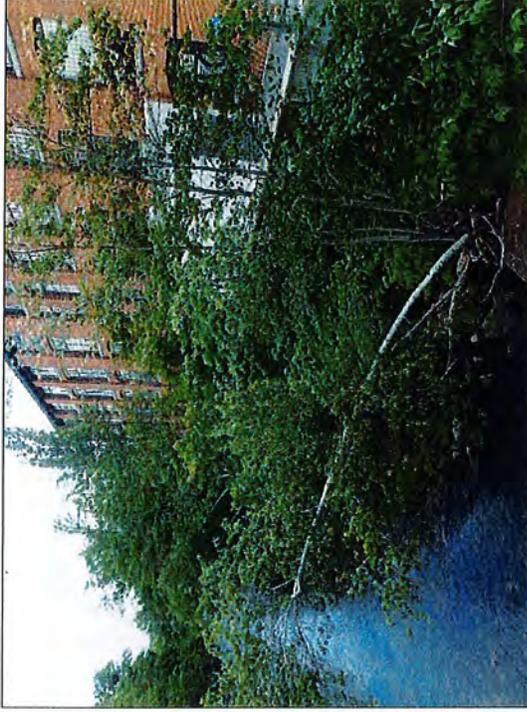
Photo 54: Oakhill Road: Heavy vegetation and leaning trees on upstream left bank.

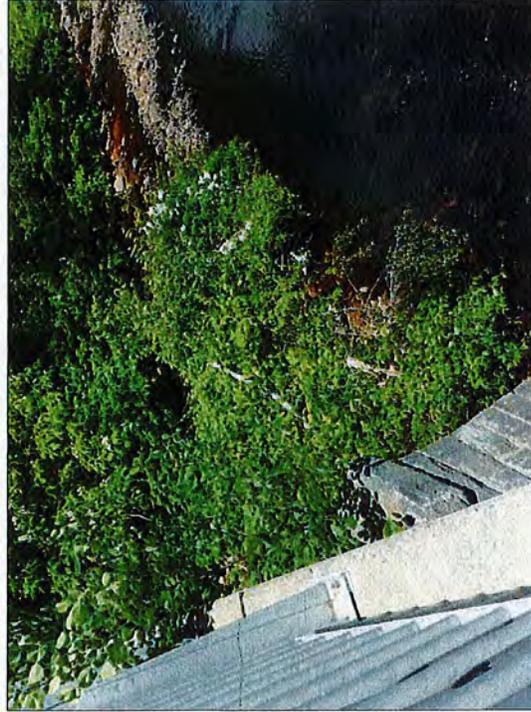
Photo 55: Oakhill Road: Heavy vegetation and shoaling on upstream right bank.

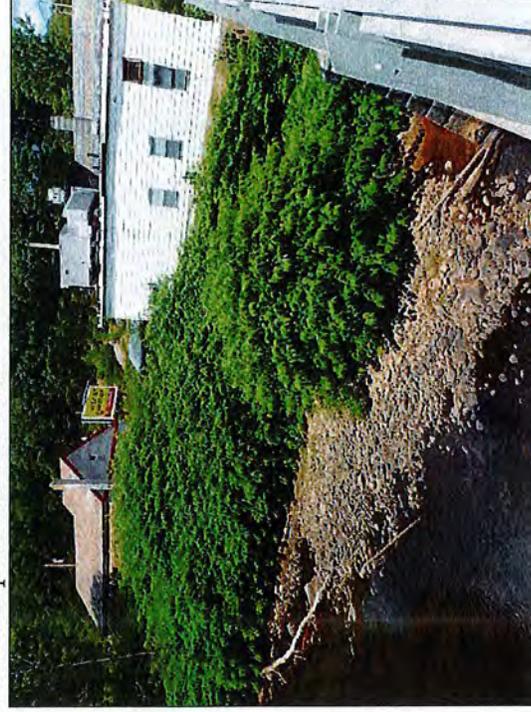
Photo 56: Oakhill Road: Heavy vegetation and shoaling on upstream left bank.
