DEPARTMENT OF THE ARMY  
US ARMY CORPS OF ENGINEERS  
NEW ENGLAND DISTRICT  
696 VIRGINIA ROAD  
CONCORD MA 01742-2751

The most recent routine inspection (RI) of the federally constructed North Nashua River Flood Damage Reduction (FDR) System, in the city of Fitchburg, Massachusetts, was conducted on June 28, 2019. Enclosed is a detailed inspection report for the City's records.

Flood Damage Reduction Segment / System  
Inspection Report

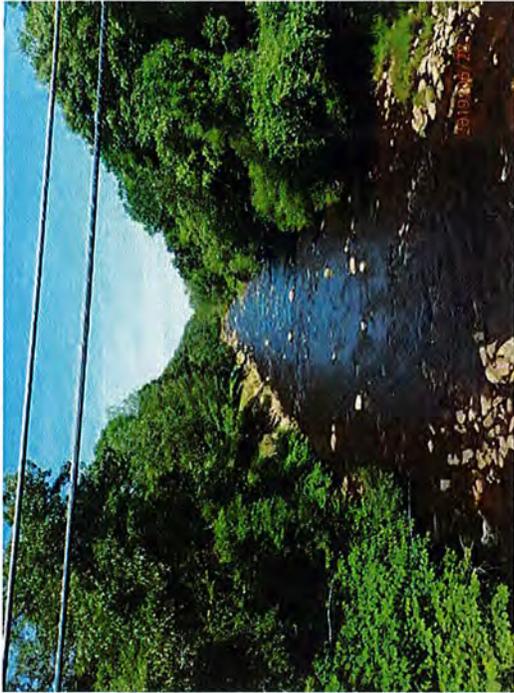
**Photo 1:** Bemis Road: View of vegetation and shoaling upstream.

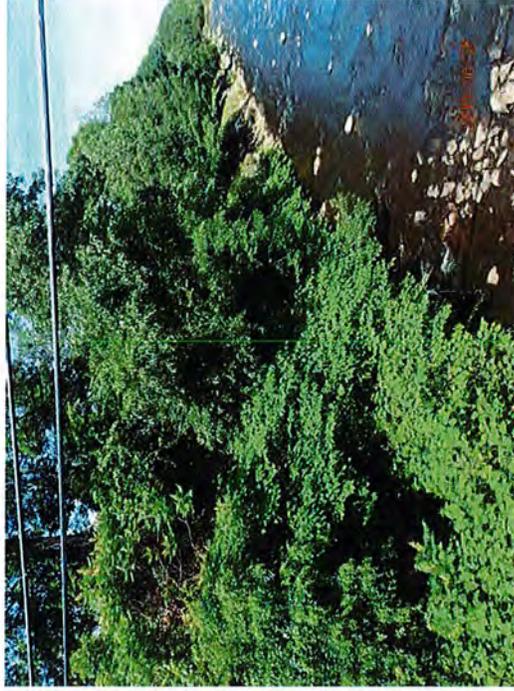
**Photo 2:** Bemis Road: View of heavy vegetation and shoaling.

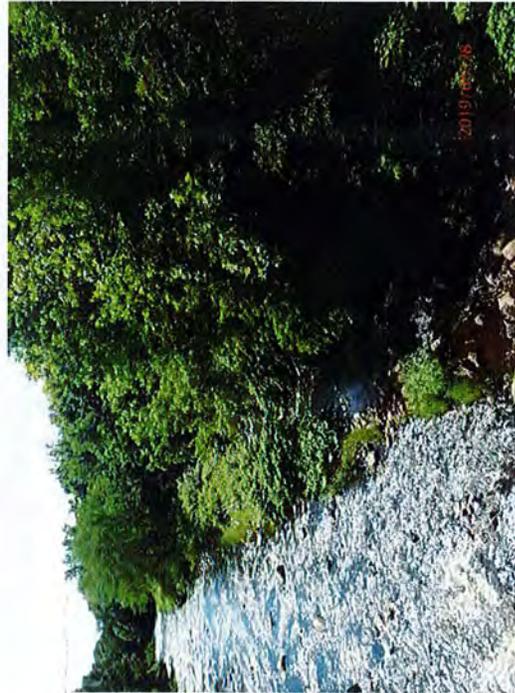
**Photo 3:** Bemis Road: View of heavy vegetation and shoaling along the upstream left bank.

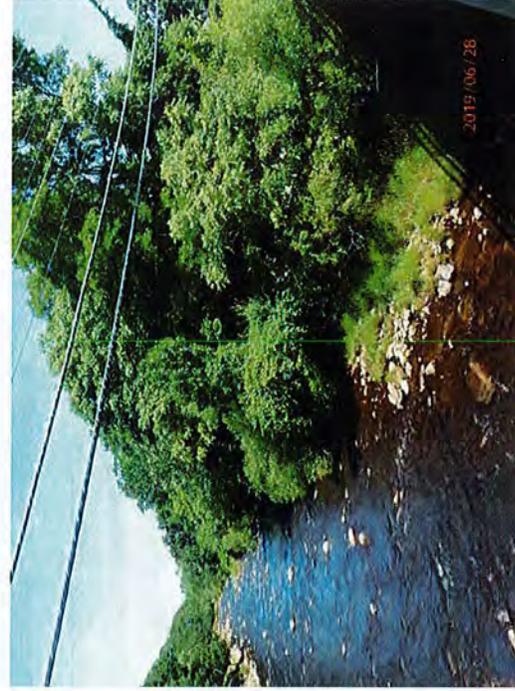
**Photo 4:** Bemis Road: View of heavy vegetation and shoaling.

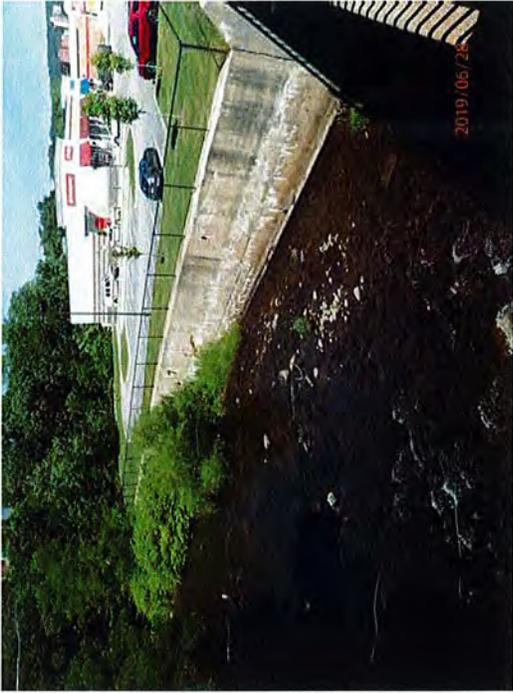
**Photo 5:** Water Street: View of vegetation and shoaling.

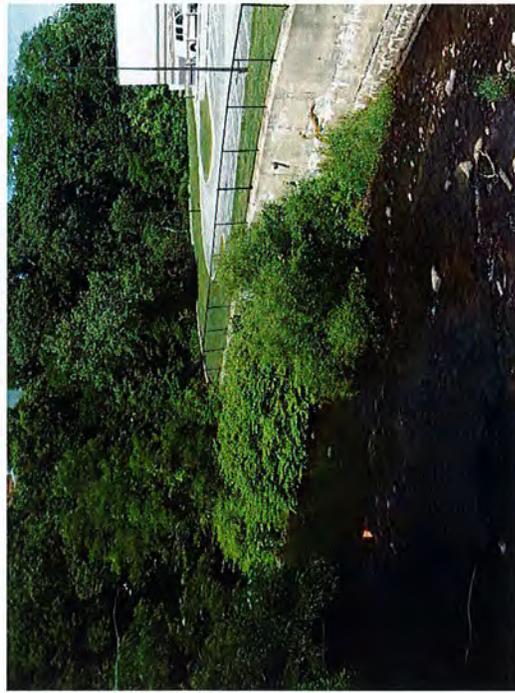
**Photo 7:** Water Street: View of heavy vegetation and shoaling along the upstream left bank, below the fence.

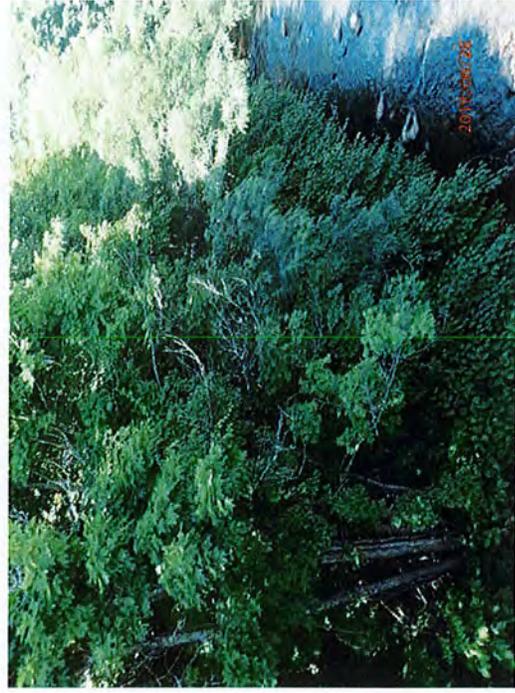
**Photo 8:** Water Street: View of vegetation along the upstream right bank.

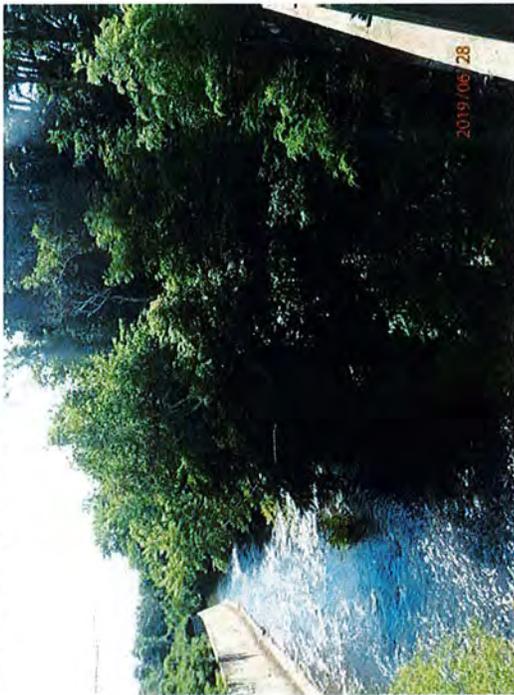
**Photo 9:** Water Street: Heavy vegetation and shoaling on the downstream right bank.

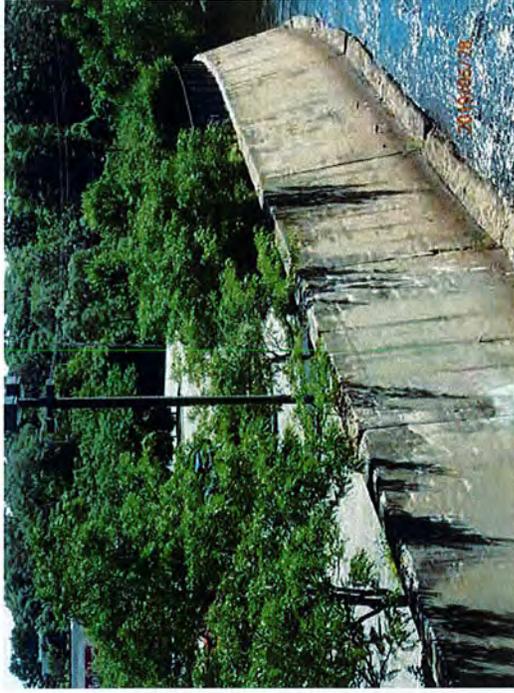
Rated Item	Rating	Rating Guidelines	Location/Remarks/Recommendations
5. Concrete Surfaces	U	Head cutting and horizontal deviation of more than 1 foot from the designed grade or cross section. Corrective actions required to stop or slow erosion.	wall near the bridge (Photo 28-29). Clear vegetation, restore displaced riprap, and provide USACE with an update. (U)
	A	Negligible spalling, scaling or cracking. If the concrete surface is weathered or holds moisture, it is still satisfactory but should be seal coated to prevent freeze/thaw damage.	Most of the floodwalls could not be inspected due to high vegetation. Floodwalls that were visible had significant deterioration. Clear vegetation and provide USACE with an update. (U)
	M	Spalling, scaling, and open cracking present, but the immediate integrity or performance of the structure is not threatened. Reinforcing steel may be exposed. Repairs/ sealing is necessary to prevent additional damage during periods of thawing and freezing.	Efflorescence and cracking noted along multiple floodwall sections. Refer to photo 6, 10, 11, 58, 60. (U)

**Photo 10:** Water Street: View of floodwall cracks, trees on upper and lower flat spaces, and shoaling along the downstream left bank.

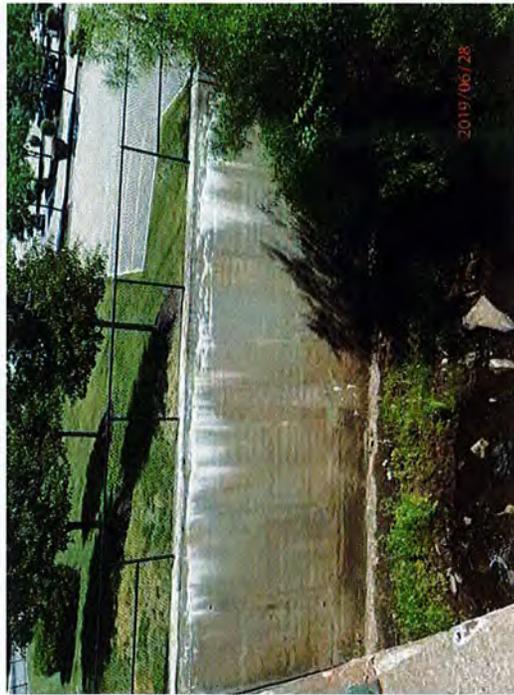
**Photo 11:** Water Street: View of efflorescence on floodwall.

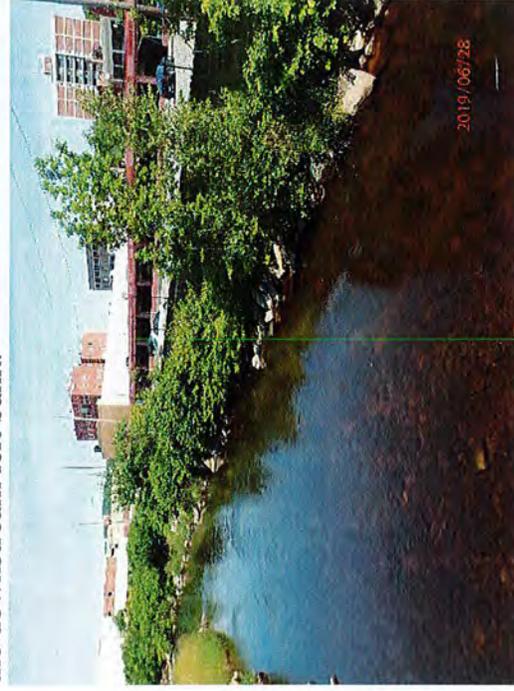
**Photo 12:** Commercial Street: Heavy vegetation along the upstream left bank.

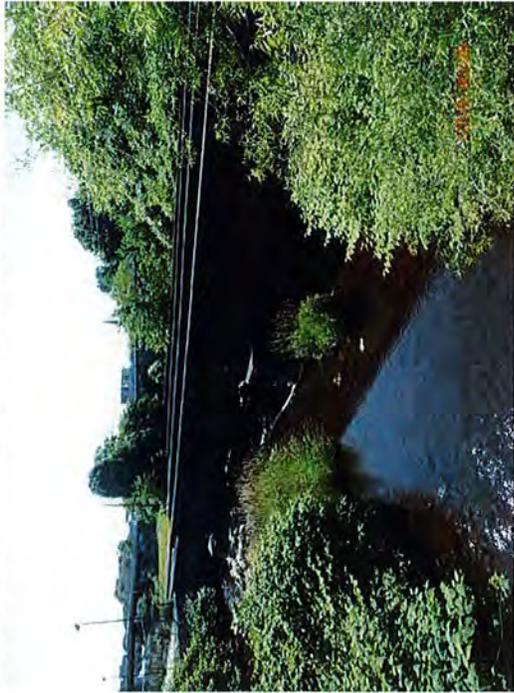
**Photo 13:** Commercial Street: Heavy vegetation on right bank looking downstream.

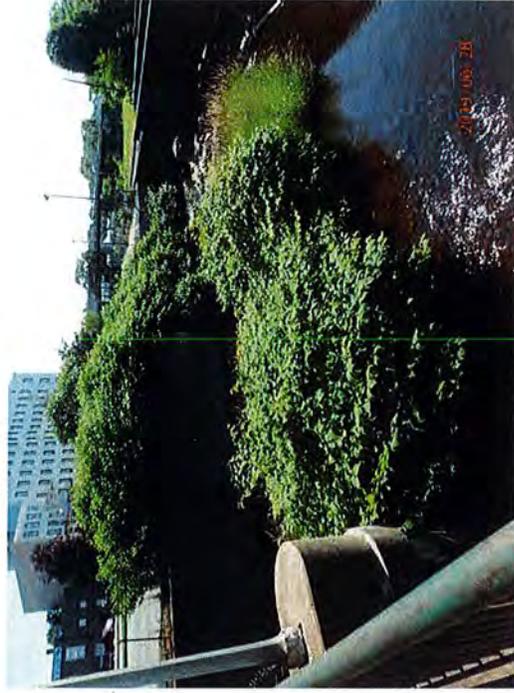
**Photo 14:** Commercial Street: Heavy vegetation on left bank looking downstream.

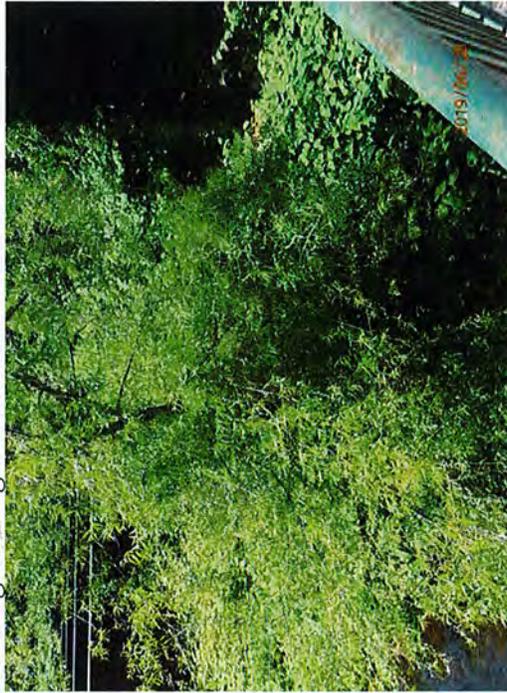
**Photo 15:** Commercial Street: Heavy vegetation on right bank looking downstream.

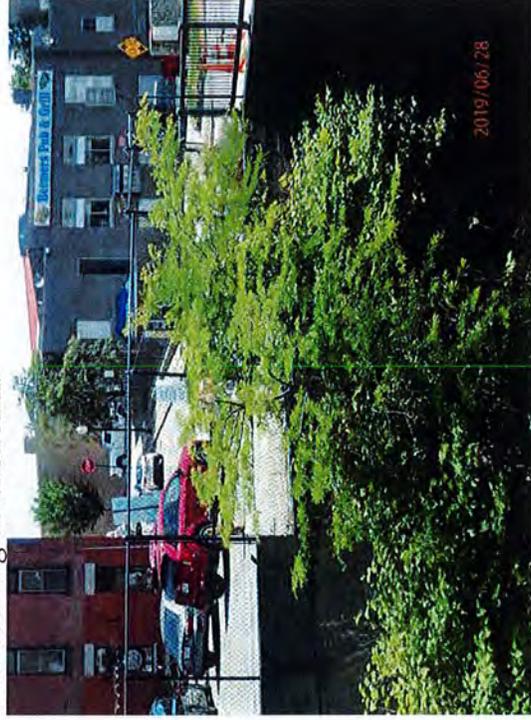
U	Surface deterioration or deep cracks present that may result in an unreliable structure. Any surface deterioration that exposes the sheet piling or lies adjacent to monolith joints may indicate underlying reinforcement corrosion and is unacceptable.	Gaps appear to have been created in the floodwall where the top foot or more of the floodwall has been removed from several locations along Putnam Street and Commercial Street (Photo 16). Repair and provide USACE with an update. (U)

**Photo 16:** Commercial Street: View of gap in floodwall.

- Floodwalls: Gaps at the top of the floodwall system along Commercial Street and Putnam Street, where the top foot or more of the floodwall has been removed, should be repaired. Spalling and efflorescence was noted along many of the floodwalls and should be evaluated and repaired. Prior to reconstructing the removed portion of the floodwall, submit repair plans to USACE for review and approval. Provide USACE with updates as repair work is performed.

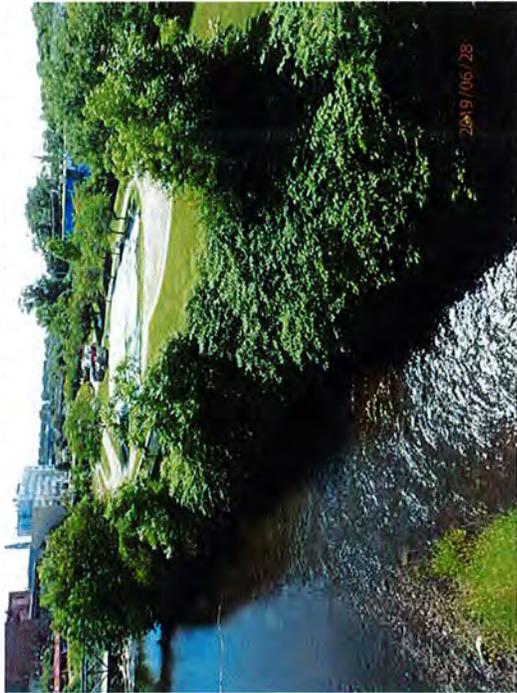
**Photo 17:** Commercial - Putnam Street: View of heavy vegetation downstream on the right bank.

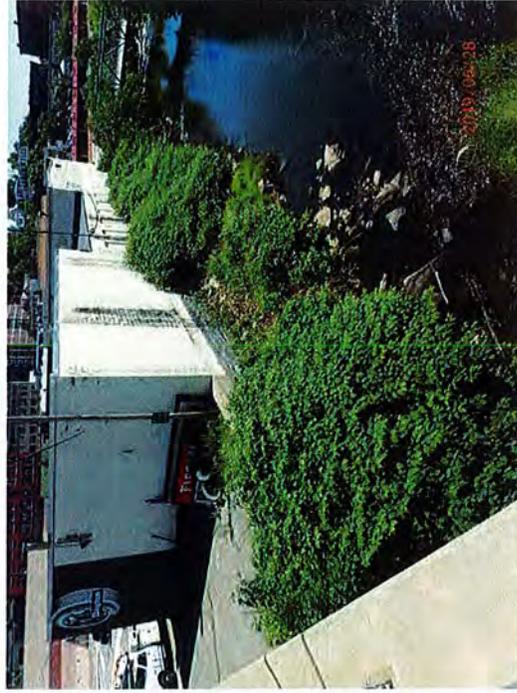
**Photo 18:** Commercial - Putnam Street: View of heavy vegetation downstream on the left bank.

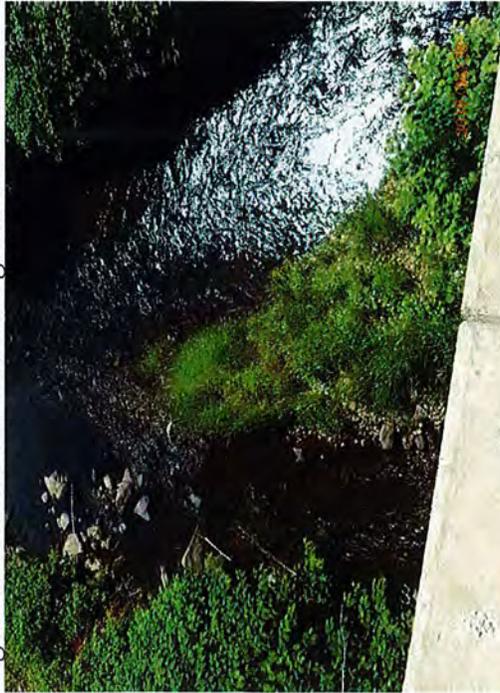
**Photo 19:** Commercial-Putnam Street: Heavy vegetation and shoaling looking downstream.

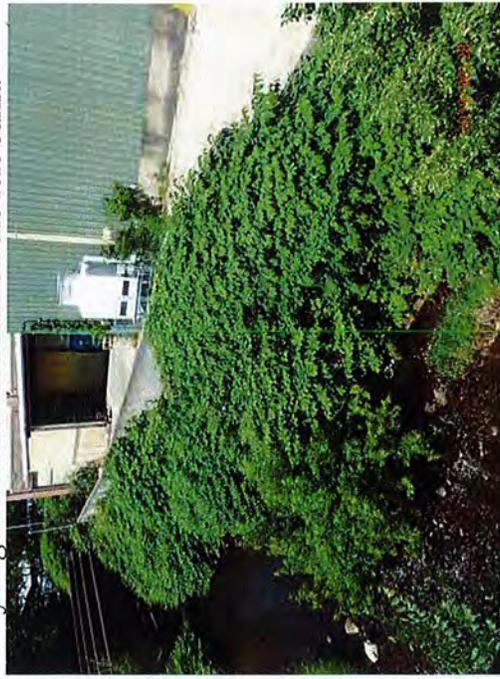
**Photo 20:** Putnam Street: Heavy vegetation on upstream left bank

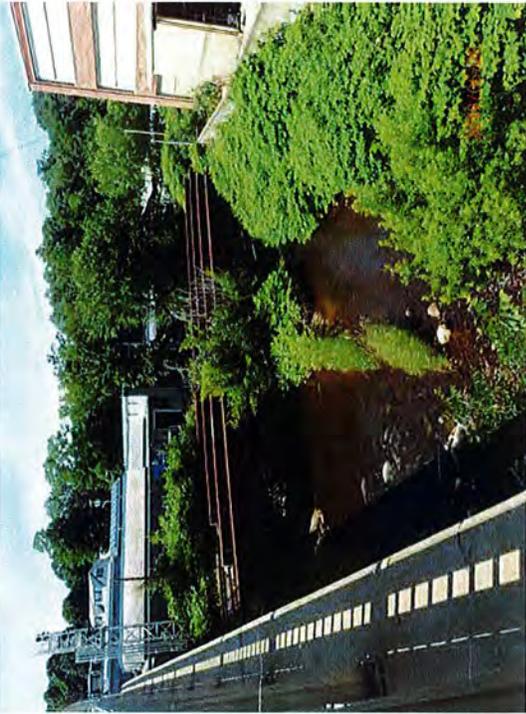
**Photo 21.** Putnam Street: Heavy vegetation and shoaling on upstream left bank.

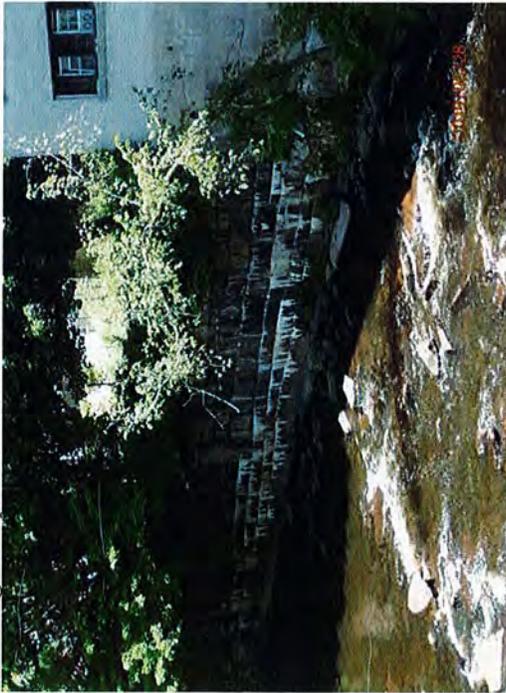
**Photo 23:** Circle Street: Shoaling and heavy vegetation.

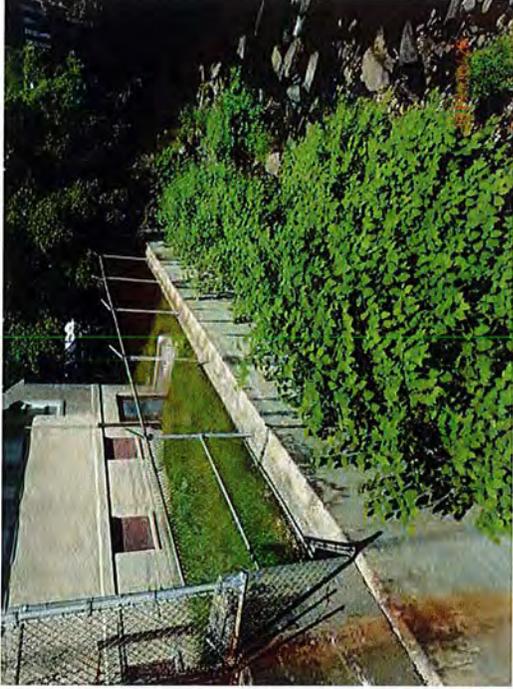
**Photo 22:** Circle Street: Heavy vegetation and shoaling upstream right bank.

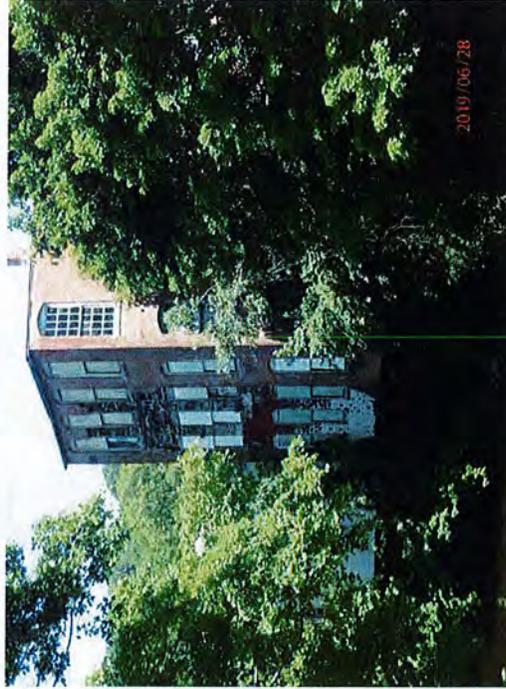
Rated Item	Rating	Rating Guidelines	Location/Remarks/Recommendations
1. Vegetation and Obstructions	U	A No obstructions, vegetation, debris, or sediment accumulation within the channel. Concrete channel joints and weep holes are free of grass and weeds.	Significant vegetation consisting of large brush and trees along the channel slopes of the entire project, with greater than 6-inch diameter trees present at each inspected segment. Vegetation needs to be cleared to prevent any reduction in flow during a flood event in accordance with Engineering Pamphlet EP 1110-2-18. Refer to photos I-60. (U)  Ornamental trees planted adjacent to the floodwall within the shopping complex by the Water Street bridge. Refer to photo 10. Remove trees. (U)  The exterior wall of a three story brick building wall on Circle Street along the left bank of the river channel is in poor condition and appears to be failing, with debris falling into the channel. The wall appears to be bowed outward toward the channel. If the wall collapses, it could block the channel. Work with the building owner to stabilize the wall and develop an emergency action plan to remove the debris from the channel if the wall collapses. Refer to photo 24. (U)

**Photo 24.** Circle Street: Failing 3-story building wall overhanging upstream, left bank.

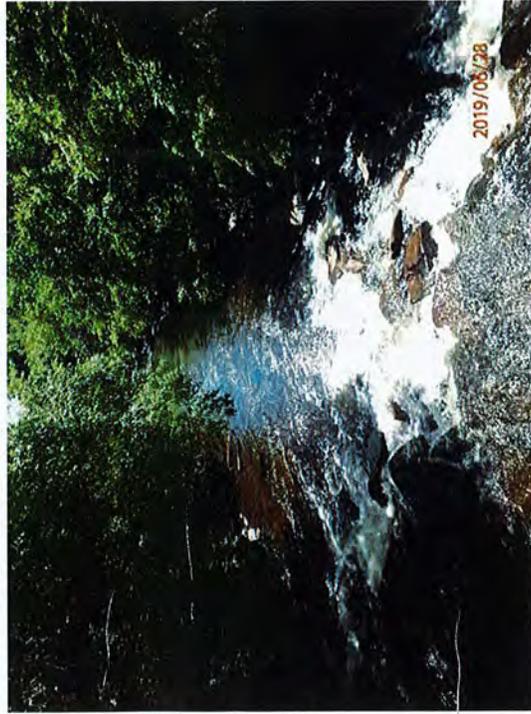
**Photo 27:** River/Main Street: View downstream of heavy vegetation.

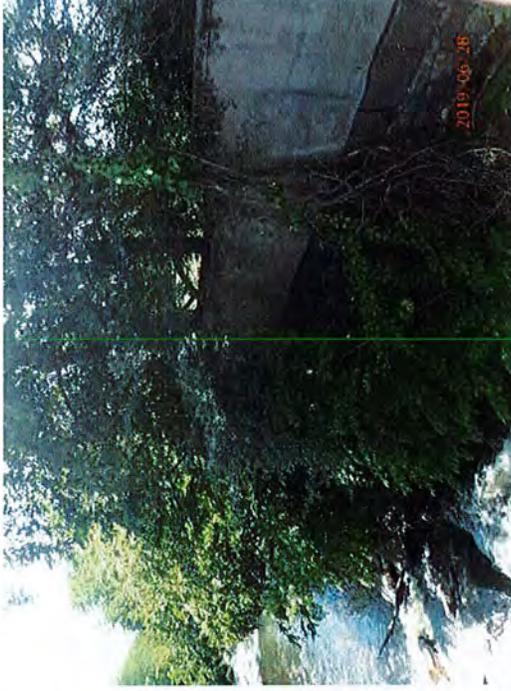
**Photo 26:** River/Main Street: Heavy vegetation and shoaling on downstream right bank.

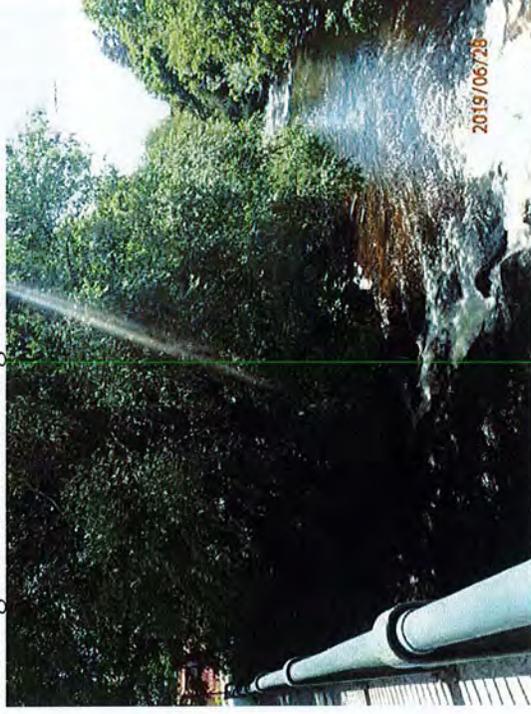
**Photo 28:** River/Main Street: Trees >6 inch diameter growing out of block joints downstream, left bank.

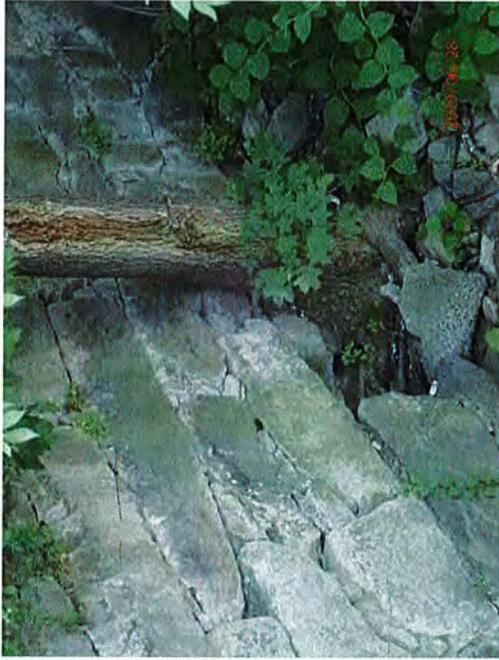
4. Erosion	U	A No head cutting or horizontal deviation observed.	Channel banks could not be inspected due to high vegetation. Trees on the downstream left bank of the River Street bridge are displacing stone blocks out of the retaining
		M Head cutting and horizontal deviation evident, but is less than 1 foot from the designed grade or cross section.

**Photo 29:** River/Main Street: 6 inch diameter tree displacing blocks out of stone wall, downstream, left bank.

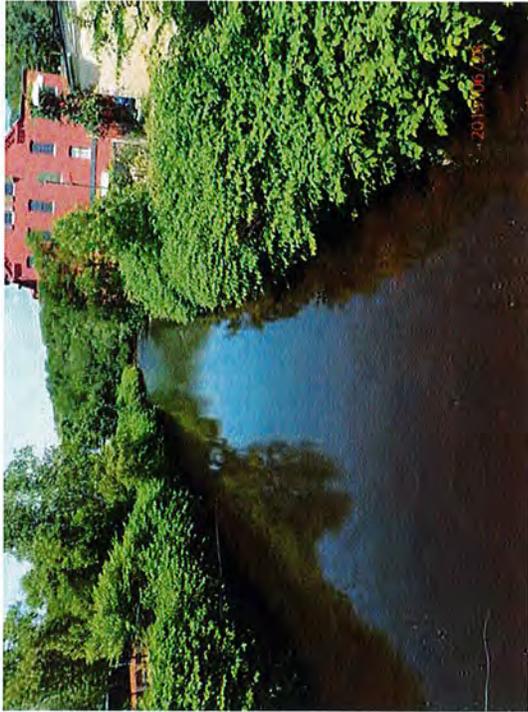
**Photo 31:** River/Main Street: Heavy vegetation and shoaling upstream left bank.

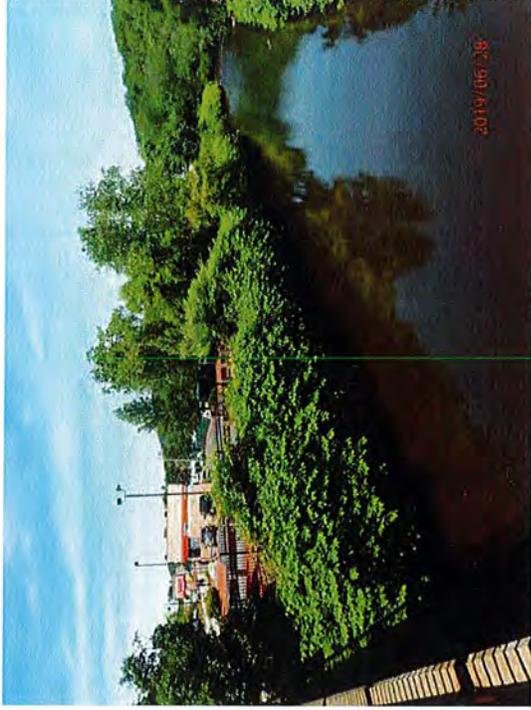
**Photo 30:** River/Main Street: Heavy vegetation and shoaling upstream right bank.

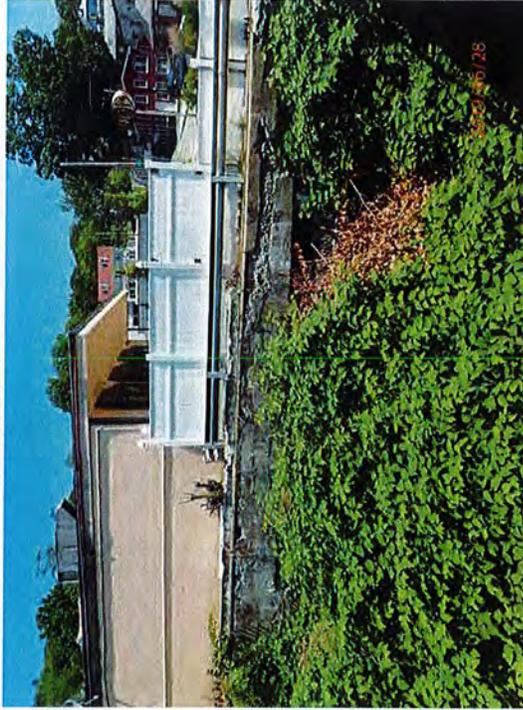
**Photo 32:** River/Main Street: Heavy vegetation on and within stone block joints, upstream left bank.

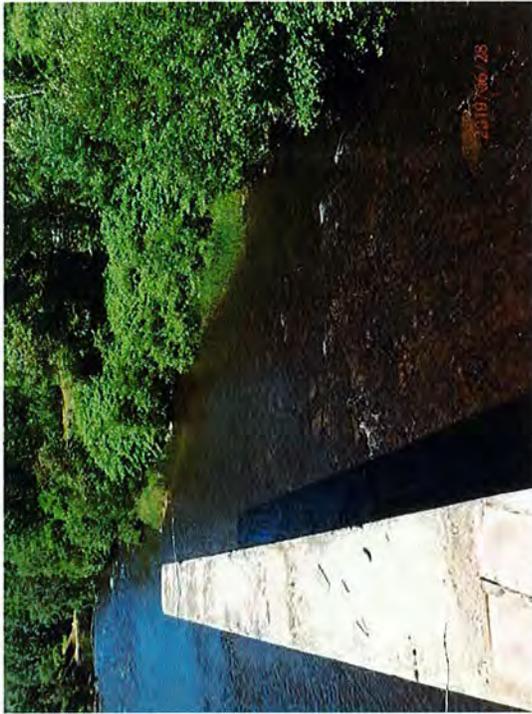
**Photo 33:** Sheldon Street: View of heavy vegetation upstream left bank.

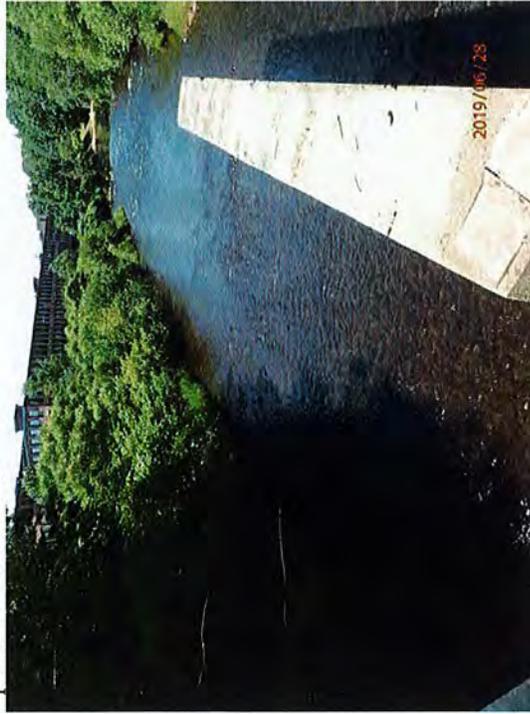
**Photo 35:** Sheldon Street: Heavy vegetation, upstream right bank.

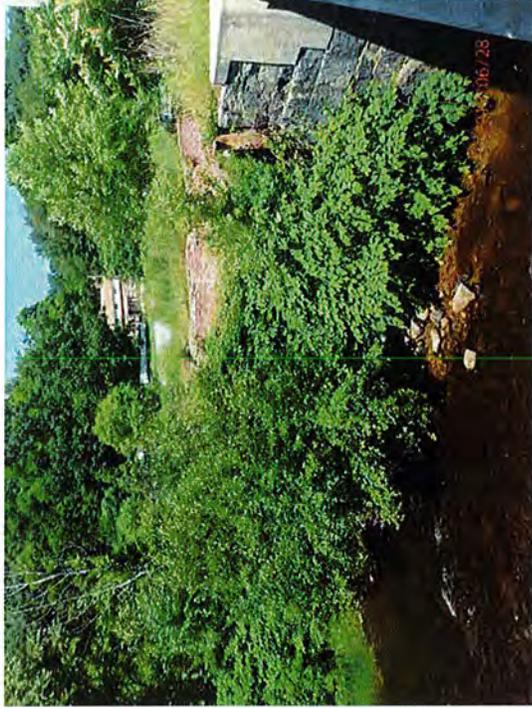
**Photo 34:** Sheldon Street: Deteriorated brick outfall (flowing), vegetation, upstream left bank.

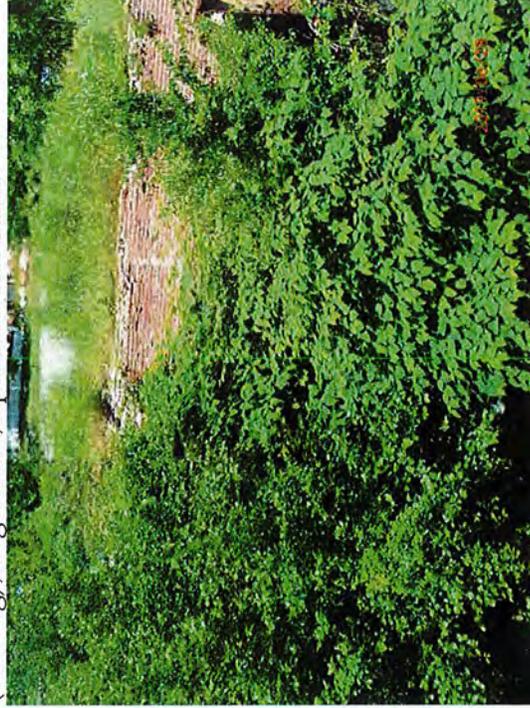
**Photo 36:** Sheldon Street: Close-up of deteriorated outfall.

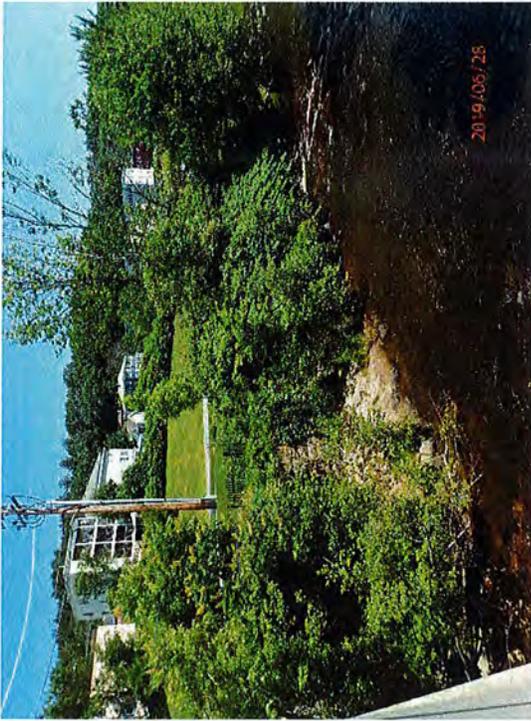
**Photo 37:** Sheldon Street: Heavy vegetation and shoaling downstream left bank.

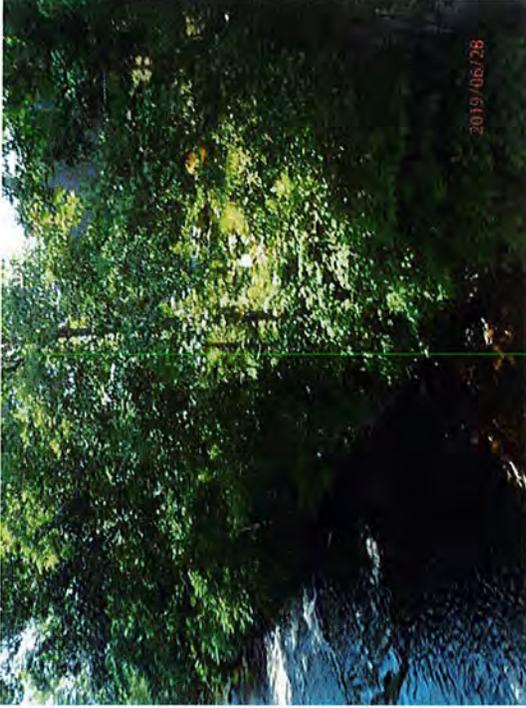
**Photo 38:** Sheldon Street: Heavy vegetation and shoaling downstream right bank.

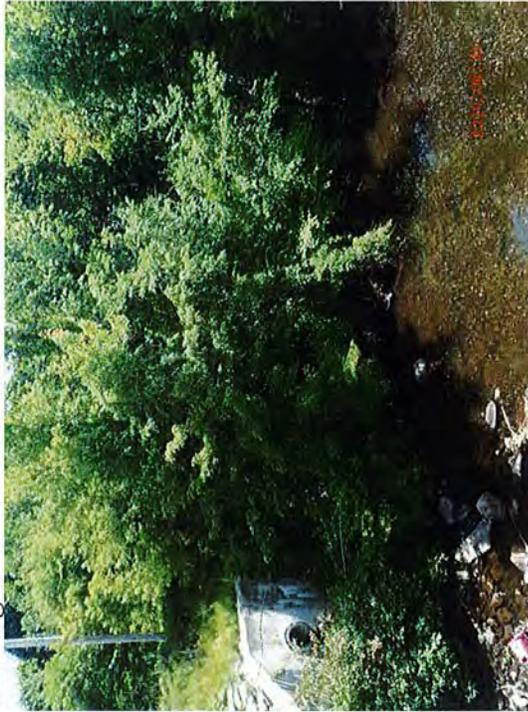
**Photo 39:** Kimball Street: View of heavy vegetation and outfall upstream right bank.

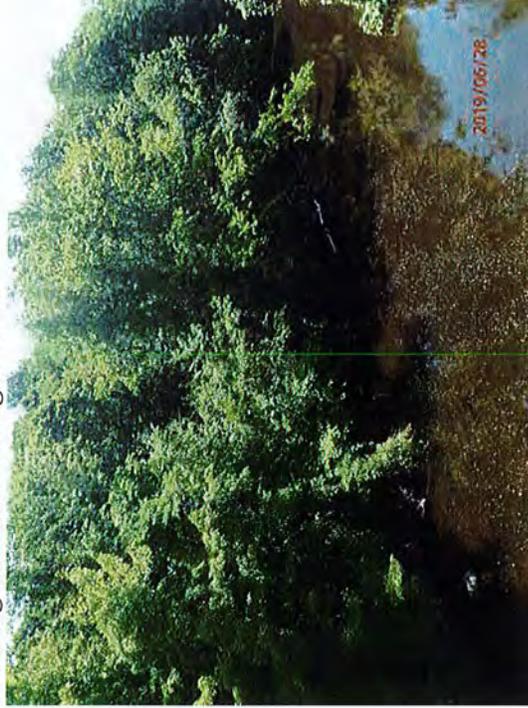
**Photo 40:** Kimball Street: Heaving vegetation upstream on right bank.

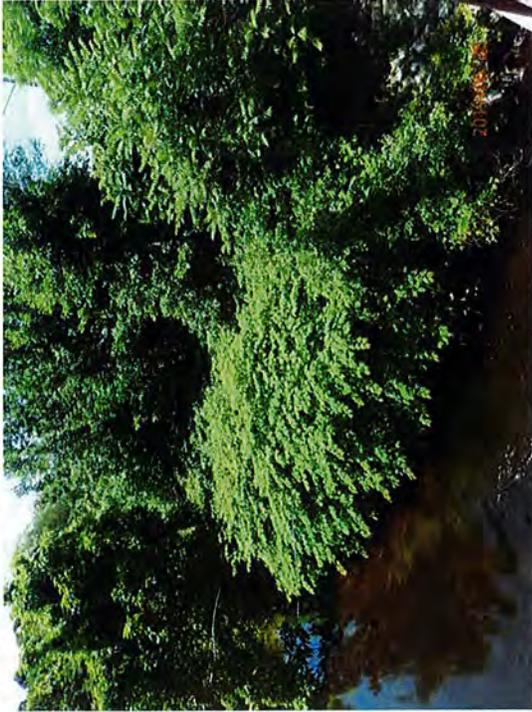
**Photo 41:** Kimball Street: Heaving vegetation upstream on left bank.

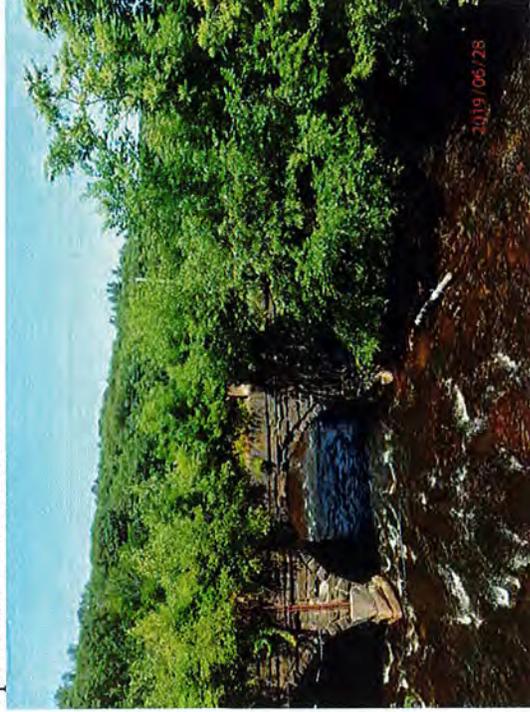
**Photo 43:** Kimball Street: Looking downstream to overgrown railroad bridge.

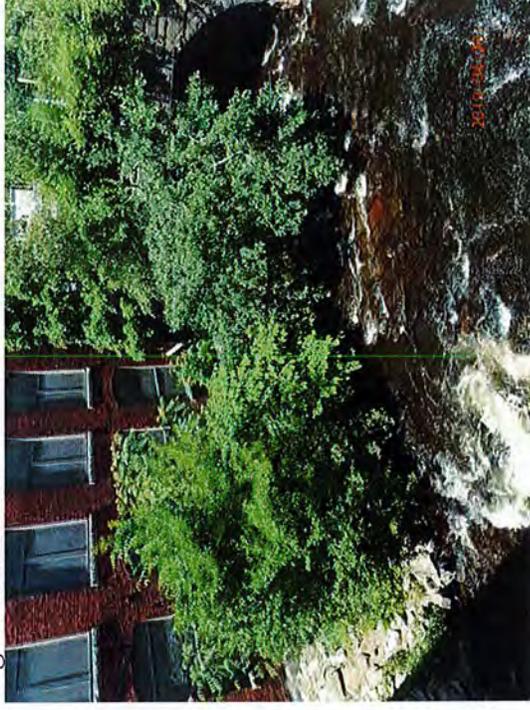
**Photo 44:** Kimball Street: Heaving vegetation on downstream left bank and railroad bridge.

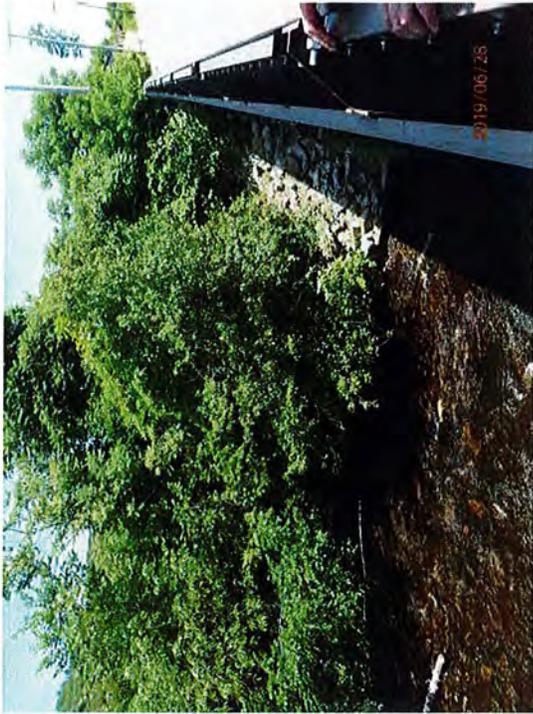
**Photo 45:** Kimball Street: Heaving vegetation on downstream right bank and railroad bridge.

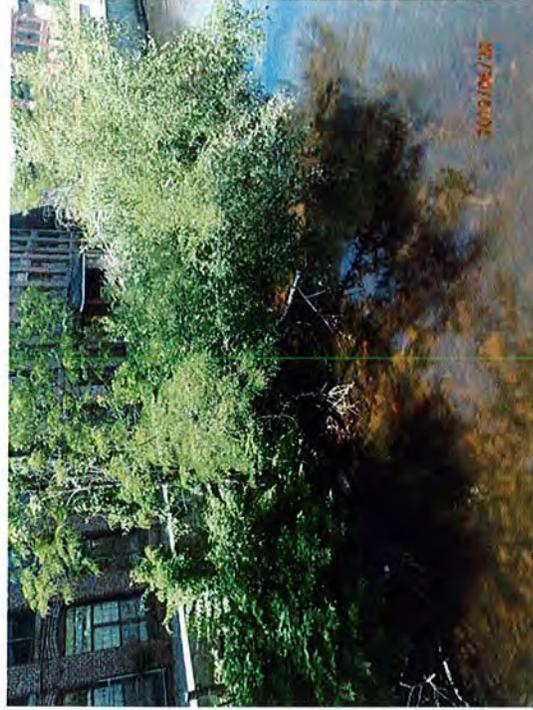
**Photo 46:** Daniels Street: Heavy vegetation and trees on upstream right bank.

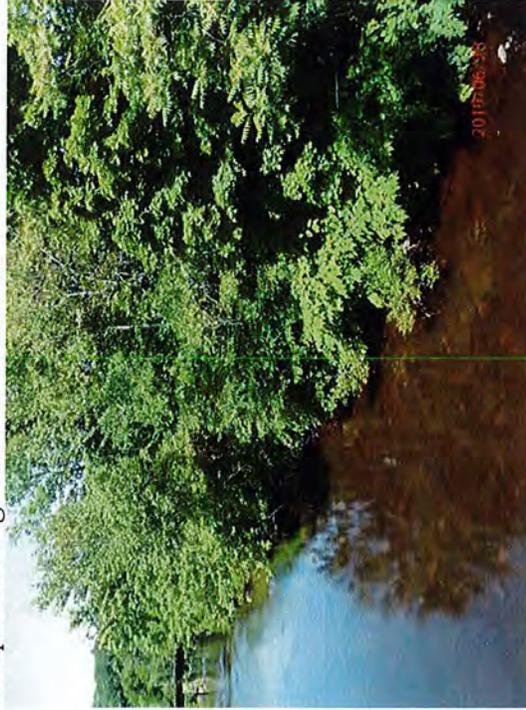
**Photo 48:** Daniels Street: Heavy vegetation on upstream left bank.

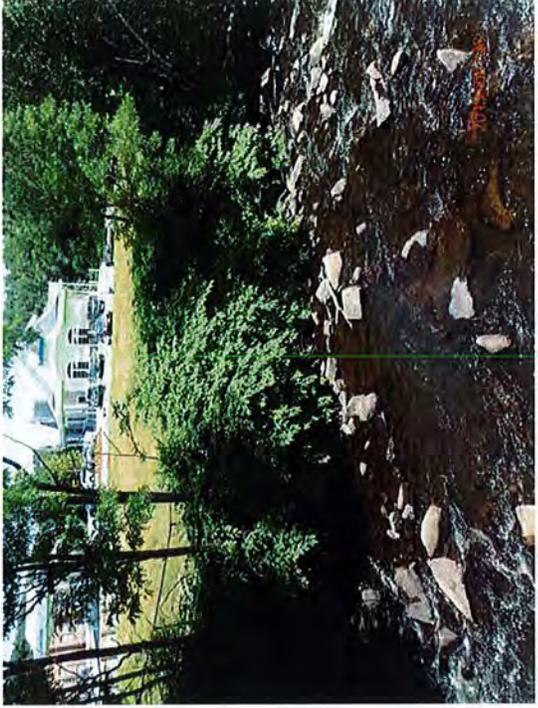
**Photo 50:** Daniels Street: Vegetation & trees downstream left bank.

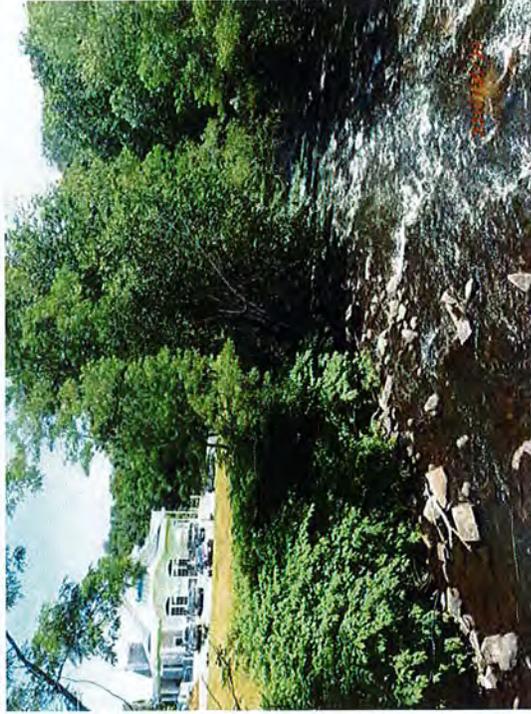
**Photo 51:** Daniels Street: Vegetation & trees downstream left bank.

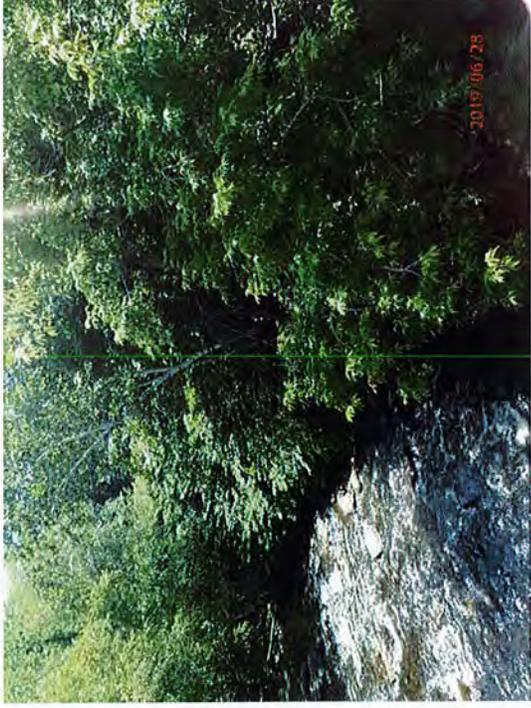
**Photo 52:** Daniels Street: Vegetation & trees downstream right bank.

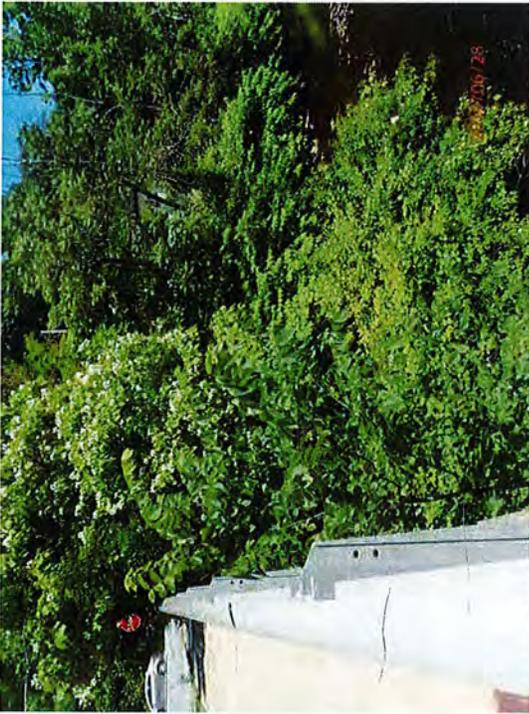
**Photo 53:** Oakhill Road: View of heavy vegetation downstream right bank.

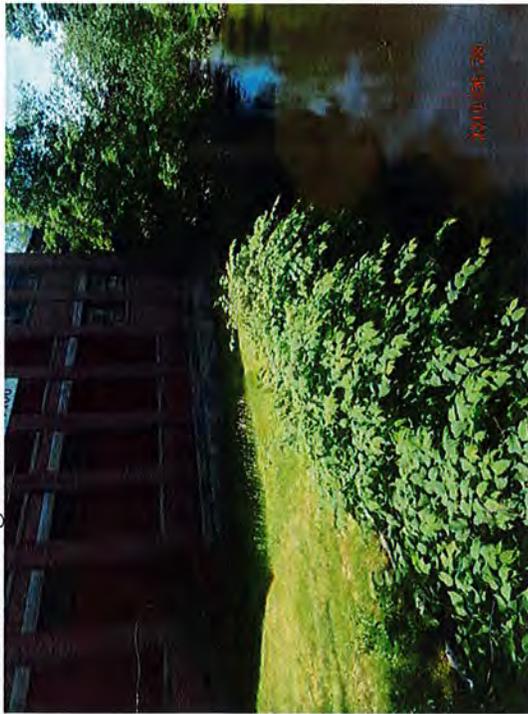
**Photo 55:** Oakhill Road: Heavy vegetation and shoaling on upstream right bank.

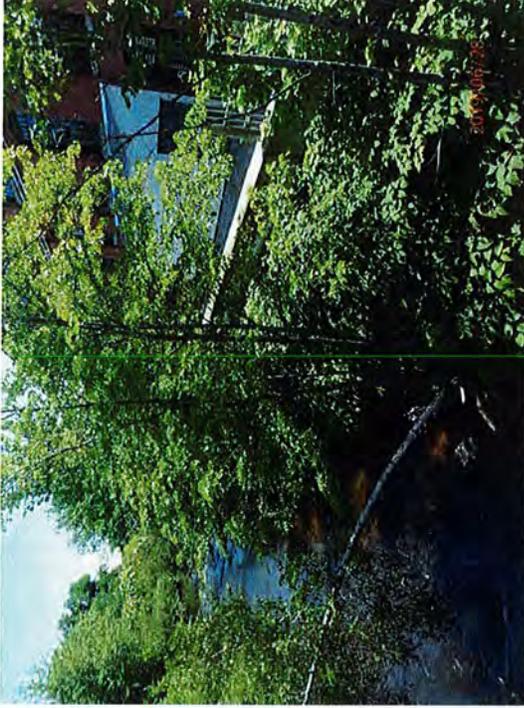
**Photo 54:** Oakhill Road: Heavy vegetation and leaning trees on downstream right bank.

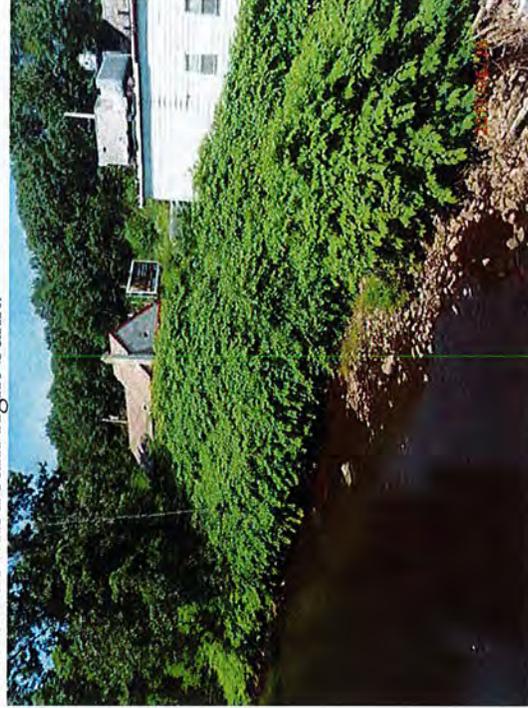
**Photo 56:** Oakhill Road: Heavy vegetation and shoaling on upstream left bank.

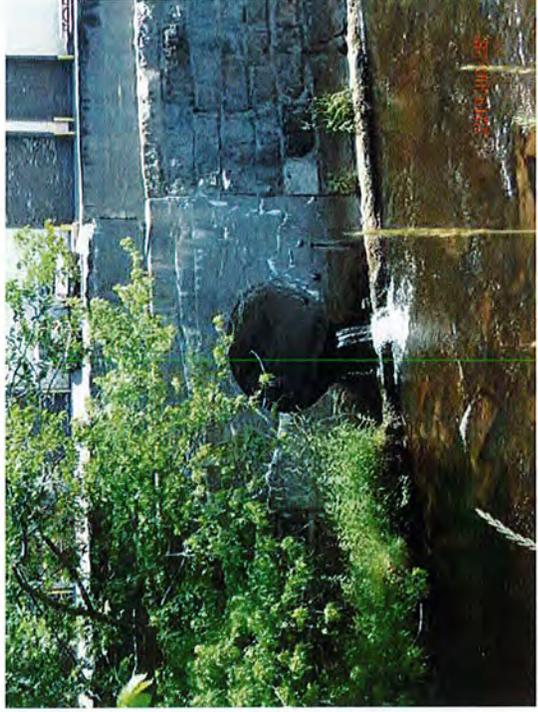
**Photo 58:** Broad Street: Deteriorating Concrete outfall.

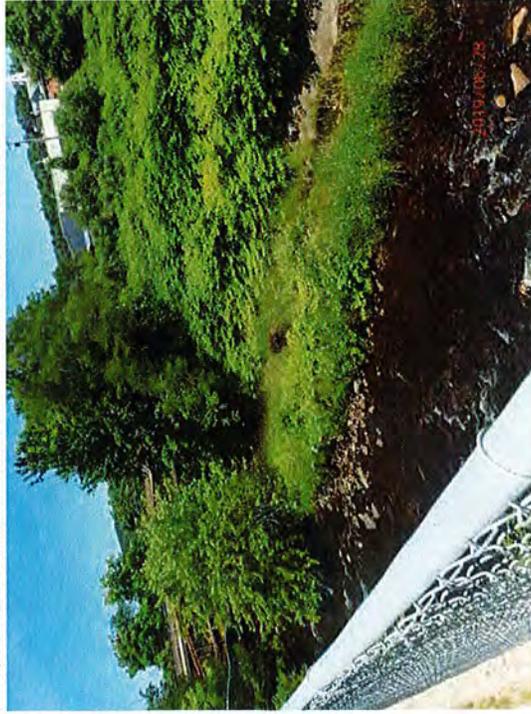
**Photo 59:** Broad Street: View of heavy vegetation on upstream left bank.

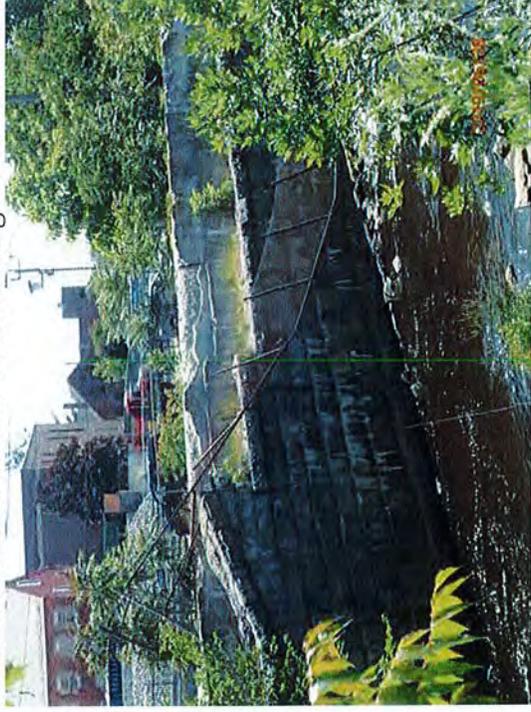
**Photo 60:** Broad Street: View of deteriorating floodwall and fallen fence, downstream left bank.
