## **FITCHBURG, MASSACHUSETTS - LOCAL PROTECTION PROJECT**

### **SEMI-ANNUAL INSPECTION**

**22 October 2003**

Project: **Fitchburg, Massachusetts**

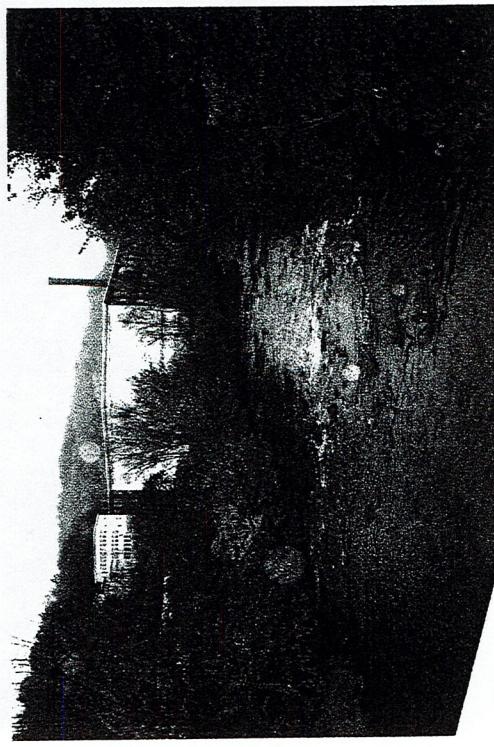
**Photo 5: Looking downstream from the Sheldon Street Bridge**

Looking downstream - Brush, trees, and other undesirable vegetation are present on both banks. A shoal is present on the left bank (see photograph # 5).

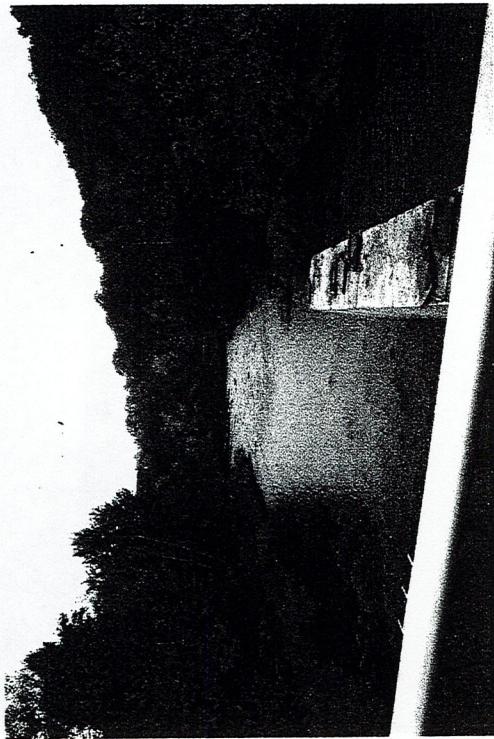
**Photo 6: Looking upstream from the Sheldon Street Bridge**

Looking upstream - Woody vegetation and shoals are present on both banks (see photograph # 6).

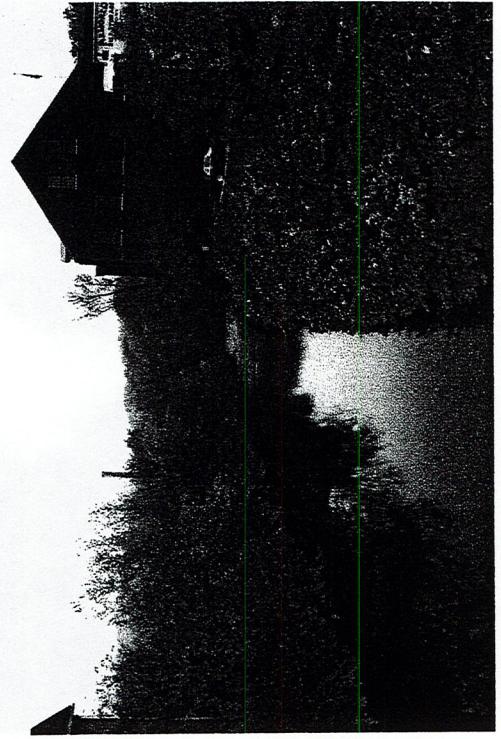
**Photo 8: Looking upstream from the Lower River Street Bridge**

Looking upstream - Vegetative growth is present along both banks (see photograph # 8).

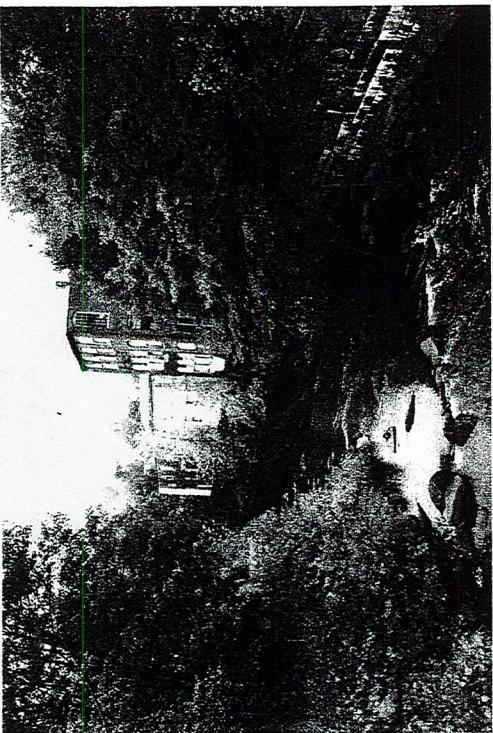
**Photo 10: Looking upstream from the Circle Street Bridge**

Looking upstream - Trees and brush growing in the training walls along both banks should be removed. The shoal on the left side of the channel should be removed (see photograph # 10).

*The reach upstream of the bridge is a second priority flood prone area primarily due to shoaling.*

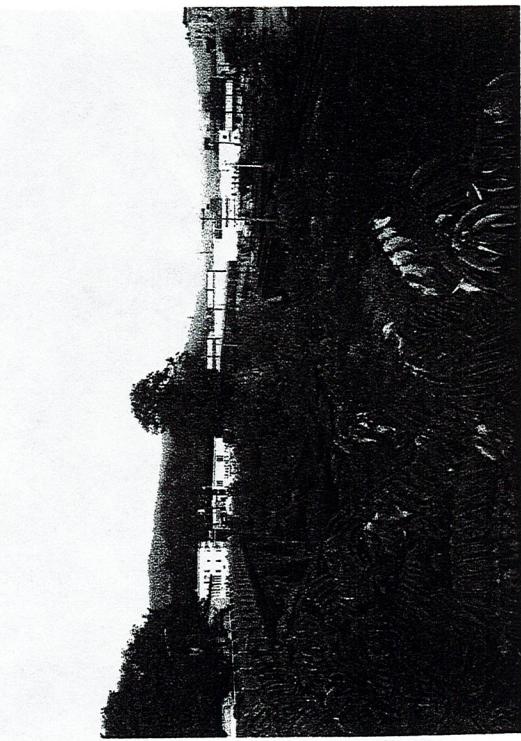
**Photo 11: Looking upstream from the Putnam Street Bridge**

Looking upstream – There is heavy growth of trees and vegetation in the training walls along both sides of the river, extending well upstream of the railroad bridge. This is also a narrow stretch of the river and should be kept free and open. The shoals on the north (right) bank approximately 100 yards above the railroad bridge and under the right span of the railroad bridge should be removed. The large shoal in the center of the channel about 200 yards upstream of the railroad bridge should be removed. The large elm growing on a shoal at the center bridge pier and the shoal at the railroad bridge center abutment should be removed (see photographs # 11 & 12).

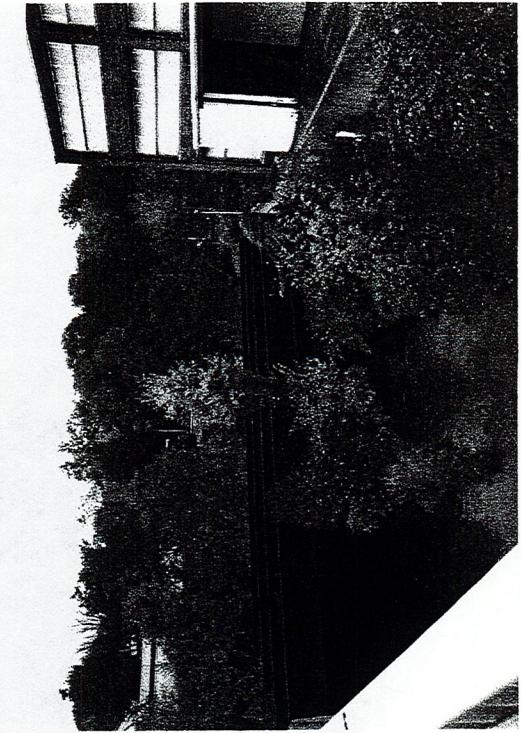
**Photo 12: Looking upstream from the Putnam Street Bridge towards the Railroad Bridge**

The trees and shrubs growing in the channel in the vicinity of the railroad bridge should be removed (see photograph # 12).

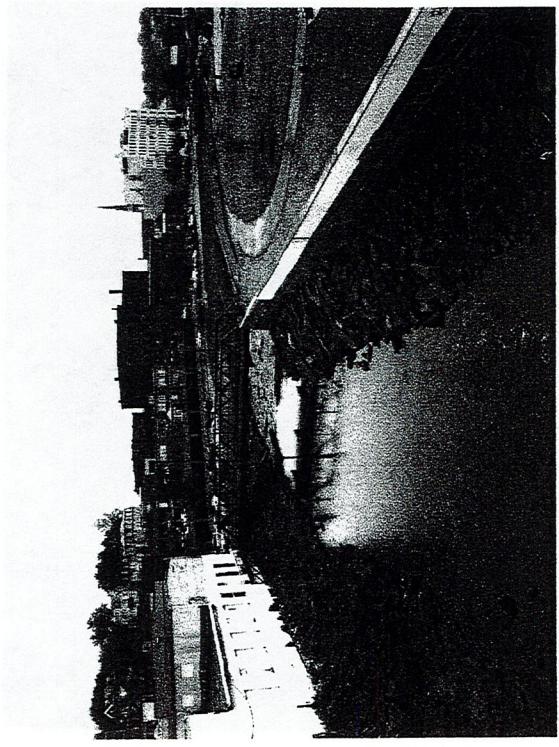
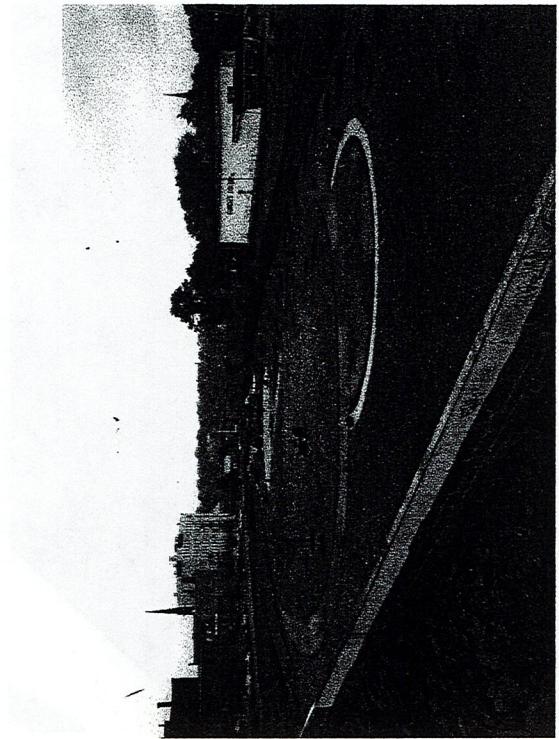
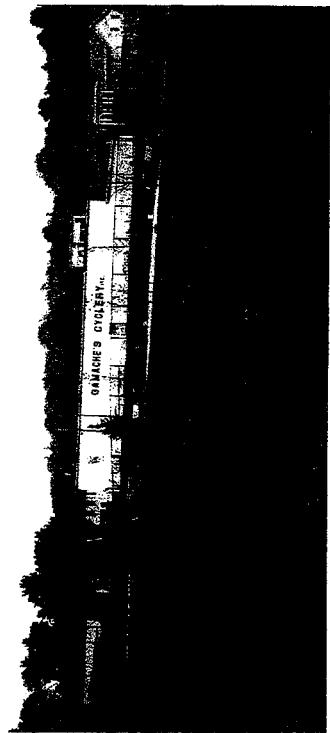
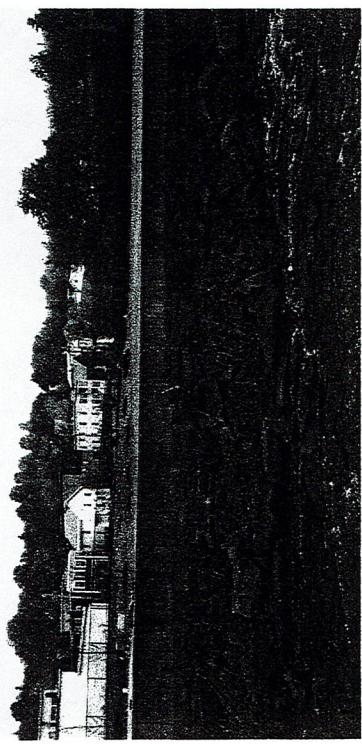
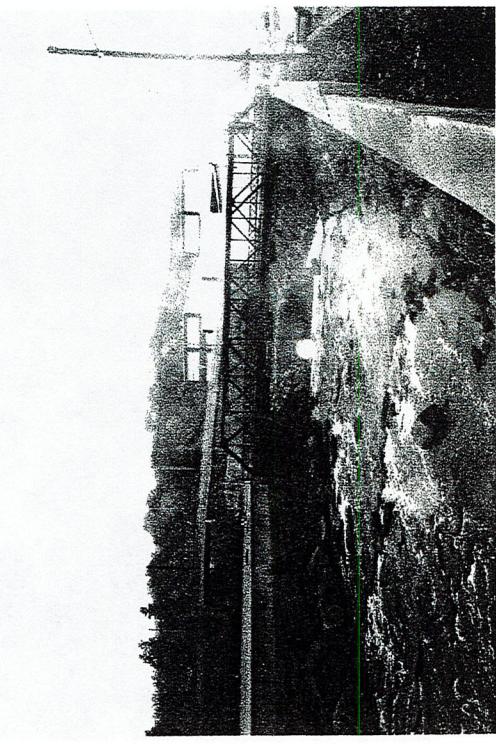
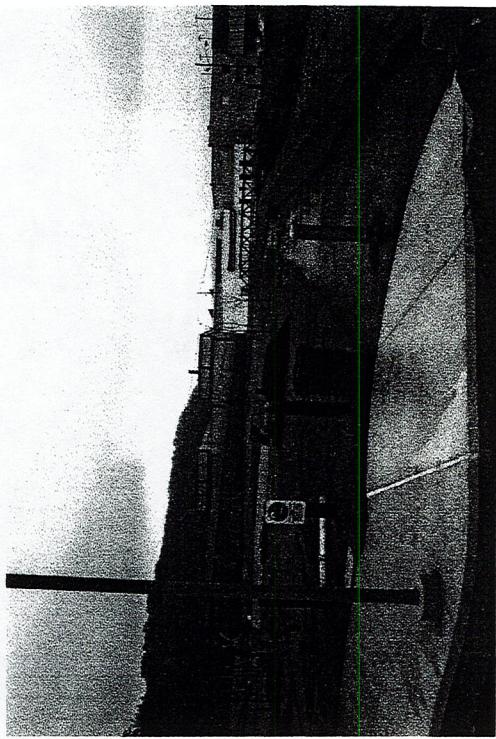
Looking downstream - All trees, brush and other vegetation has been cut and removed from within the floodwalls and riprap along both sides of the river extending from the Putnam Street Bridge to the just beyond the Cushing Street bridge in conjunction with the new riverfront park (see photographs # 13, 14, 19, 20, 21, 22, 23, 24, 25 & 26).

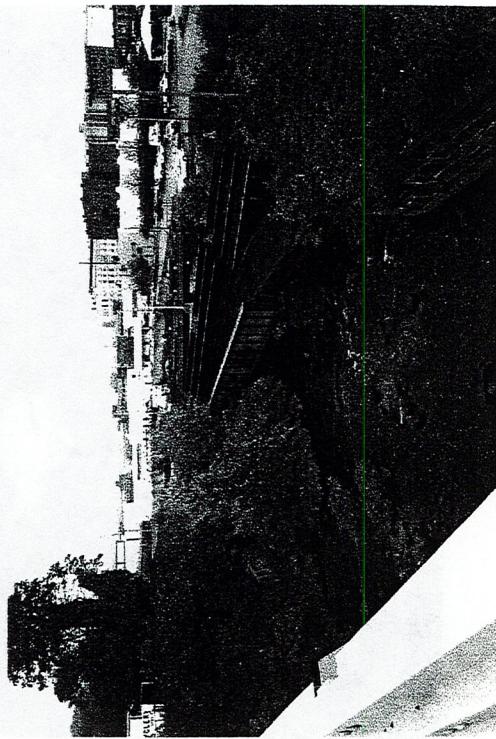
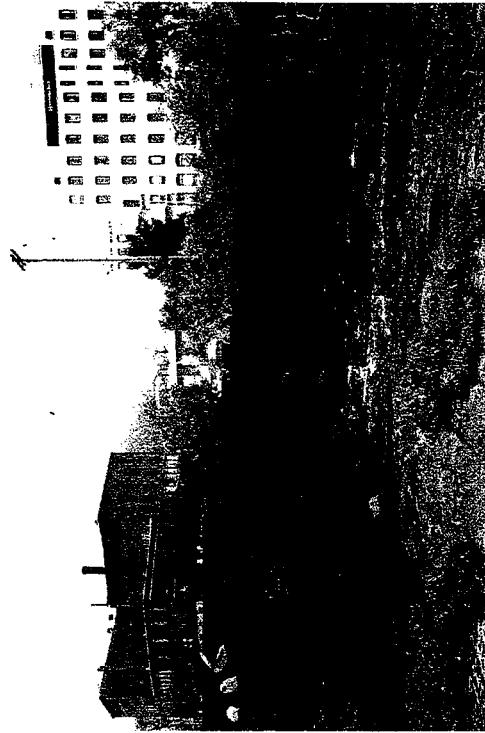
Looking upstream - Major shoaling has taken place in the entire area of the upstream railroad crossing. A large shoal, which is nearly covered with vegetation, restricts the western span and half of the center span. This is a significant restriction, which has decreased the discharge capacity of the channel by nearly 33% and needs to be corrected promptly. The shoals and vegetation should be removed (see photographs # 16 - 18).

**Photo 16:** Looking upstream from the Laurel Street Bridge towards the Railroad Bridge. Note the large shoal blocking the left span of the bridge

**Photo 17:** Looking upstream from under the Laurel Street Bridge towards the Railroad Bridge. Note the large shoal blocking the left span of the bridge

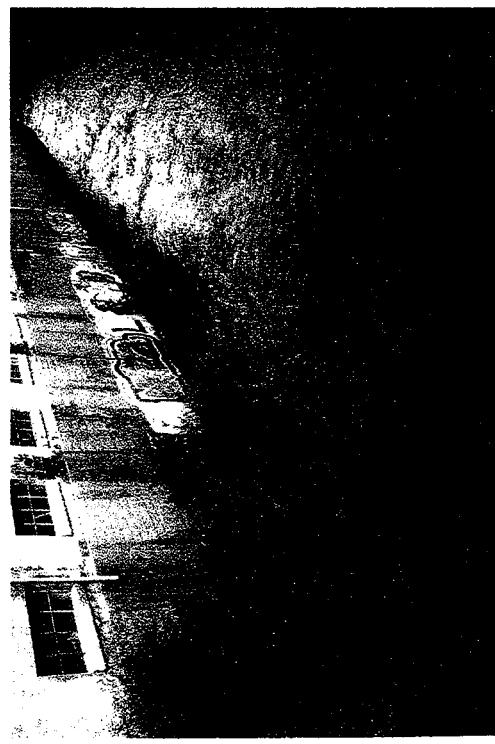
Looking downstream - A shoal has formed on the left bank adjacent to the floodwall. Numerous willow trees have become established (see photograph # 27).

**Photo 27:** Looking downstream from the Water Street Bridge . Note the large Willow growing on the shoal on the left bank.

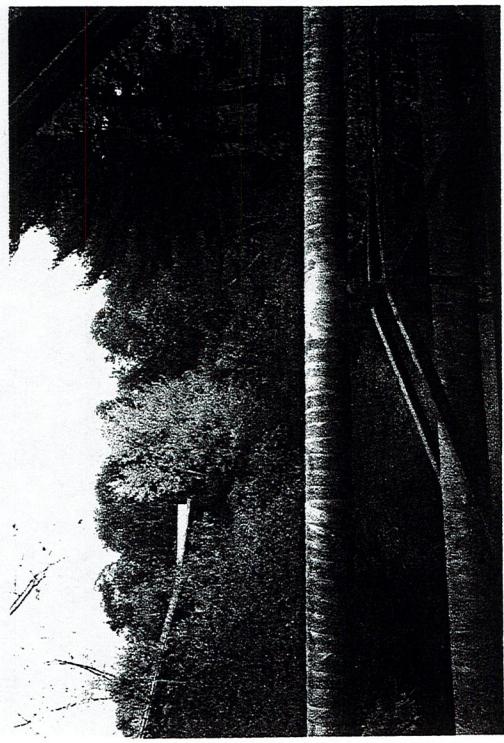
**Photo 29:** Looking downstream from the Sawyer Passway Bridge

Downstream - There is major brush, tree and vegetative growth on both banks downstream to the Fifth Street Bridge (see photograph # 29).

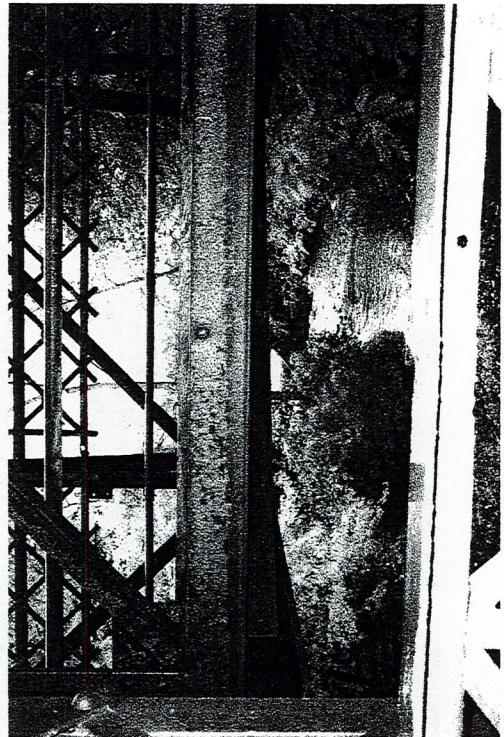
**Photo 30:** Looking downstream from the Sawyer Passway Bridge

Looking upstream - Shoaling in the center of the river above the bridge and has created a restriction within the channel and should be removed. Small trees have fallen over (see photograph # 30).
