January 6, 2003

Construction-Operations Division

It was a pleasure having you and your Economic Development staff accompany us during the October 25, 2002 inspection of the Fitchburg local protection project (LPP). I have enclosed a copy of the inspection report for your review.

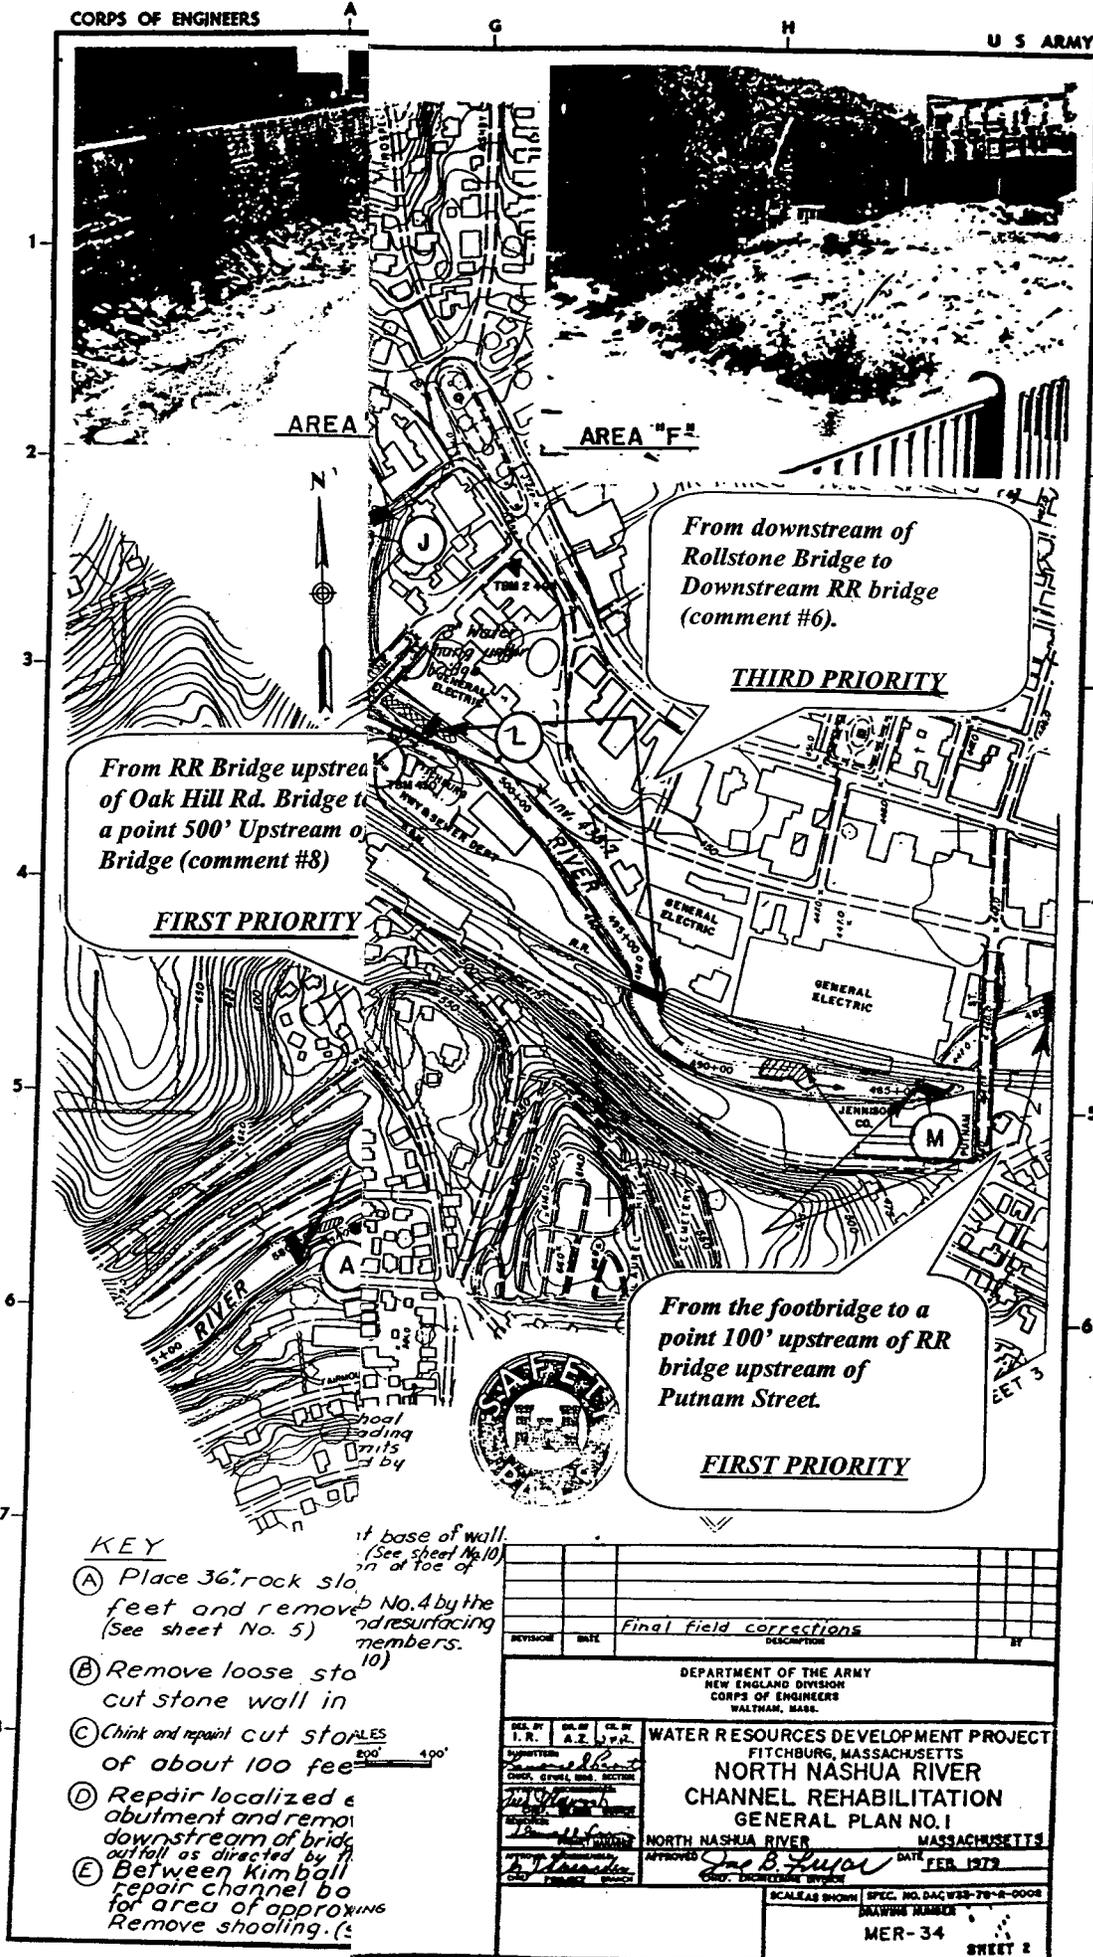
- KEY**
- (A) Place 36" rock slope at base of wall. (See sheet No. 10) in at toe of
 - (B) Remove loose stone No. 4 by the cut stone wall in and resurfacing members. (10)
 - (C) Check and repair cut stone of about 100 feet
 - (D) Repair localized abutment and remove downstream of bridge outfall as directed by
 - (E) Between Kimball repair channel bottom for area of approx. 100 feet. Remove shoaling.
